Case Studies in Engineering Failure Analysis

Effect of additional holes on transient thermal fatigue life of gas turbine casing

Keywords: Gas turbine casing Additional holes Transient thermal fatigue crack propagation life Residual stress

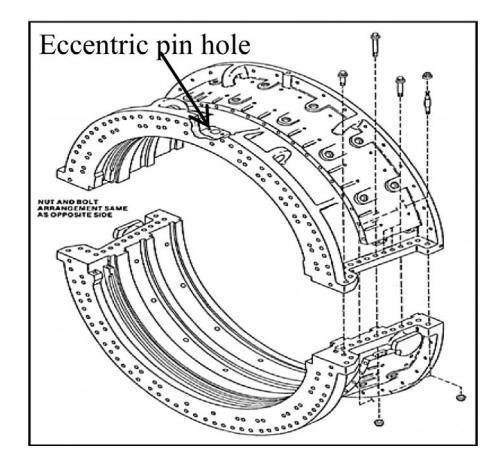
Fig. 1 shows the turbine casing (red) and a side-section view of a gas turbine. The casing consists of two half-casings made of ductile cast iron and connected by flanges. Fig. 2 is a 3D drawing of the casing showing the position of the eccentric pin hole. The position of the crack on the casing surface was investigated using non-destructive tests. Fig. 3 shows a sample crack determined by penetrant testing. Table 1 lists the results of chemical analysis of the casing material and indicates good correlation with ASTM-A395 ductile cast iron. Table 2 lists the mechanical properties of ASTM-A395 ductile cast iron.

Fig. 2. 3D drawing of upper half-casing and location of eccentric pin hole.
