# Inappropriate Implantable Cardioverter-Defibrillator Therapy During Surgery: An Important and Preventable Complication

Marc A. Rozner, PhD, MD<sup>\*,†</sup>, Edward A. Kahl, MD<sup>‡</sup>,  
Peter M. Schulman, MD<sup>‡</sup>

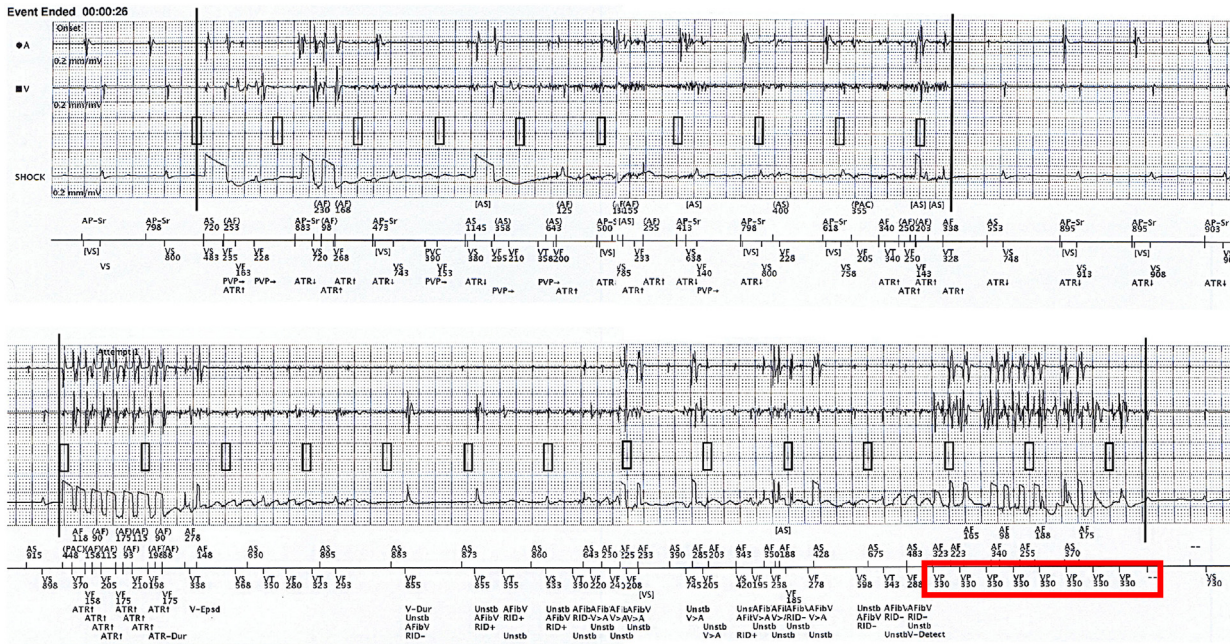
The event log and stored electrogram (Fig 1) demonstrated delivery of inappropriate ATP resulting from EMI during endoscopic sinus surgery at a community hospital. Although preoperative notes from both the surgeon and anesthesiologist acknowledged the ICD, the hospital record contained no discussion of device parameters, plans to mitigate EMI, or recognition that EMI occurred. There was no mention of device reprogramming or magnet application. Operating room

Fig 1. Electromagnetic interference (EMI) sensed by the implantable cardioverter-defibrillator (ICD) as atrial fibrillation, ventricular tachycardia, and ventricular fibrillation led to antitachycardia pacing during sinus surgery. The ICD treatment record showed about 9 seconds of EMI, followed by about 4 seconds of no EMI, then just over 1 second of EMI, leading to the episode onset (V-Epsd). The ATP was delayed because of the “unstable” nature of the V-V intervals (an unstable V-V interval is interpreted by the device as atrial fibrillation). Ultimately, antitachycardia pacing (ATP) (highlighted in the red box) was delivered because the ventricular rate was greater than the atrial rate and because of the failure of the QRS morphologic match (RID-). Recordings (top to bottom) are atrial lead electrogram, ventricular lead electrogram, shock lead electrogram (approximates a surface electrocardiographic signal), and markers reflecting the ICD decision tree. The tall rectangles (added to figure) indicate 1 second intervals (paper at 25 mm/sec). -, uncategorized and ignored event (usually due to blanking issues); AF, atrial fibrillation event; AFibV, indication that the ICD is counting ventricular tachycardia or ventricular fibrillation events even though its mode has been switched for atrial tachyarrhythmia; AP, atrial pace (-SR indicates that the rate sensor was active); AS, atrial sense—(AS) indicates that the AS event was ignored for ventricular pacing purposes; ATR, a counter that determines a pacing mode switch from DDD (atrial tracking) to DDI because of atrial tachyarrhythmia (eg, atrial fibrillation; arrow direction indicates increment [up] or decrement [down]. At ATR-DUR, the ICD began counting a second set of atrial tachyarrhythmia events that would have led to a mode switch with 8 additional counts or a de-arming of the atrial tachyarrhythmia event with 8 normal A-A sequences); PAC, premature atrial electrical event; PVC, ventricular event not preceded by an atrial event during DDD pacing mode; PVP - > , identifies the postventricular atrial refractory period that indicates that the ICD will not track an atrial sensed event; RID-, QRS morphology that does not match the stored QRS image and will lead to high voltage therapy; RID+, QRS morphology that matches the stored QRS pattern and will lead to a delay in high voltage therapy; Unstb, V-V interval variability that exceeds stability criteria used to identify AF with rapid ventricular response, which delays high-energy therapy while the V rate is lower than the VF rate but higher than the minimum treatment rate; V > A, indication that the ventricular rate is greater than the atrial rate—V > A overrides nearly every other parameter that might delay high-energy therapy; V-Epsd, start/end of a ventricular tachydysrhythmic event; VF, ventricular event sensed in the ventricular fibrillation window; VP, ventricular pace; VS, ventricular sense; [VS], ventricular noise event; VT, ventricular event sensed in the ventricular tachycardia window.

records showed use of monopolar electrosurgery during the case and placement of the electrosurgery unit dispersive electrode on the thigh. The data of the prior interrogation stored in the ICD memory demonstrated the lack of preoperative or postoperative examination of the ICD. Neither the patient nor any of his medical providers had any knowledge of this event.
