Case Report

Inadvertent placement of a urinary catheter into the ureter: A report of 3 cases and a review of the literature

Department of Urology, Changi General Hospital, Singapore

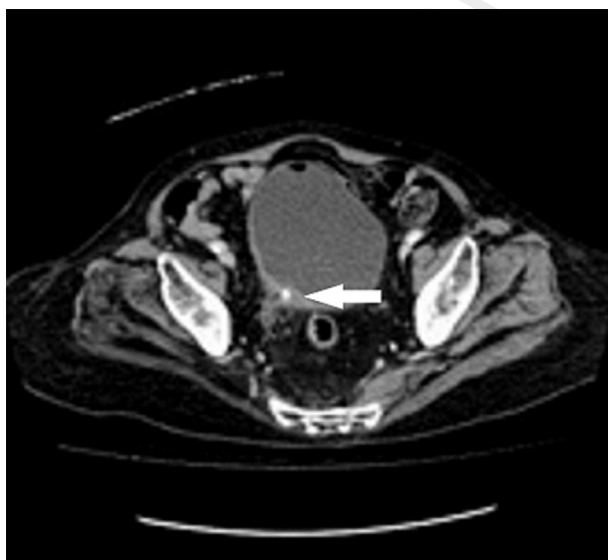
Contrast-enhanced computer tomographic scan of his abdomen and pelvis (CT AP) demonstrated the tip of the urethral catheter to be located within the right vesicoureteric junction (VUJ) and obstructing it with resultant acute right hydronephrosis and hydroureter (Figs. 1 and 2). The right kidney was also noted to be bulky and showed multiple non-enhancing areas with perinephric fat stranding suggestive of acute pyelonephritis.

Figure 1 CT scan, cross section: the tip of the vesicoureteric catheter within the right vesicoureteric junction.

The aberrantly placed catheter was removed and a new Foley catheter was reinserted. He was treated with intravenous Aztreonam based on positive blood and urine cultures which grew *Klebsiella pneumoniae*. The patient was

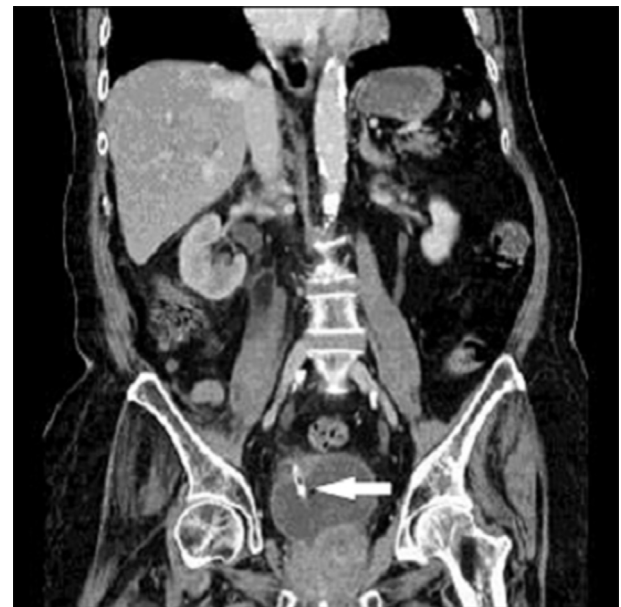
Figure 2 CT scan coronal view: the tip of the catheter within right vesicoureteric junction.
