Engineering Geology

Characterization and analysis of a translational rockslide on a stepped-planar slip surface

Tannant D.D.^{a,*}, Giordan D.^b, Morgenroth J.^a

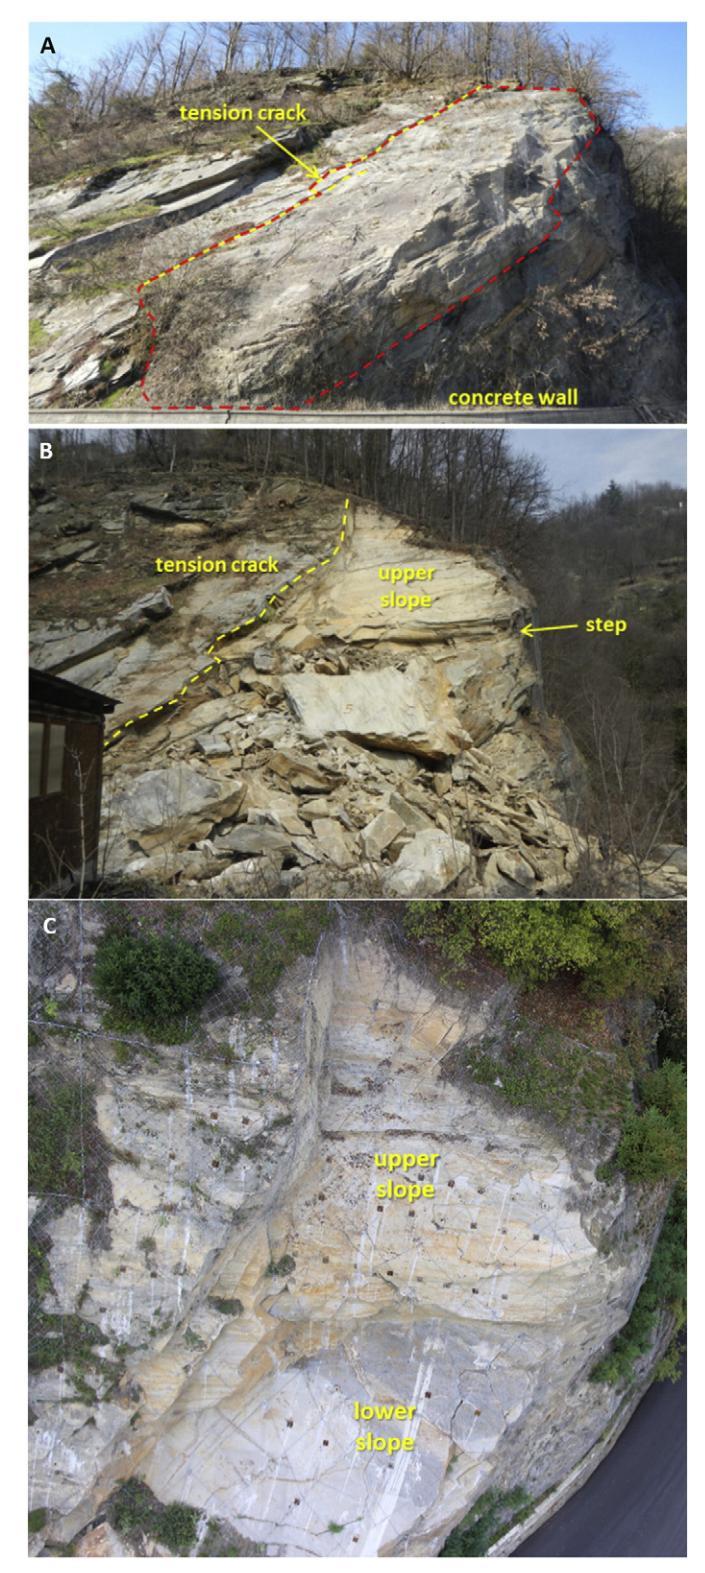
Fig. 2 shows the rock slope immediately before and after the rockslide, as well as several months after the event, in October 2014. As described by Giordan et al. (2015a,b), the dataset of images and videos recorded by the drone were very useful during the first phases of emergency response to this rockslide and led to a timely decision to close the road. After the collapse, the images were used to analyse the new condition of the rock slope and to help design rock stabilization works. For the first surveys, over 400 image frames were extracted from a video shot of the pre-failure slope with a GoPro Hero 3 Black camera mounted to a multi-rotor UAV. After the slope failed, photos were taken with the same GoPro camera and UAV. Months later, after

Fig. 2. Rock slope (a) one day before, (b) immediately after, and (c) several months after the rockslide event.
