Engineering Failure Analysis

The effect of buoyancy force on structural damage: A case study

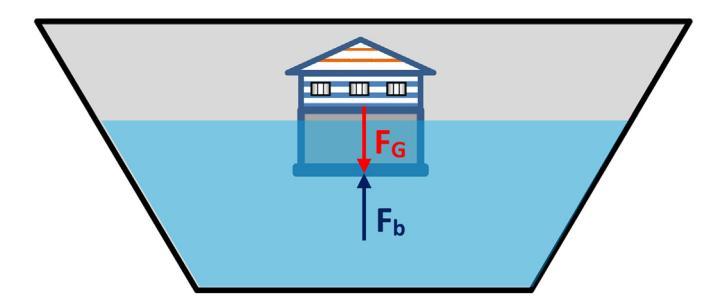
Fig. 1. The structural damage due to the buoyancy force (F_b), exceeds the weight of a structure (F_G).

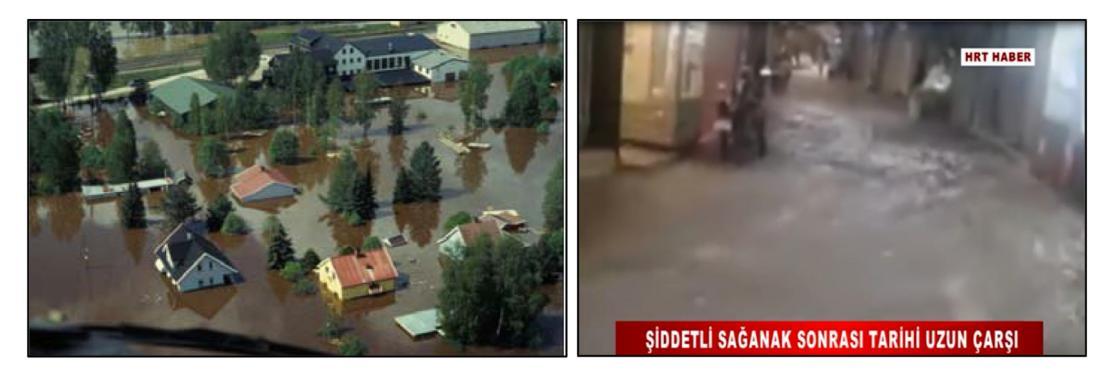
Fig. 2. City centers after floods and spates a) Damage survey [8], b) Historic Antique Bazaar in Hatay.

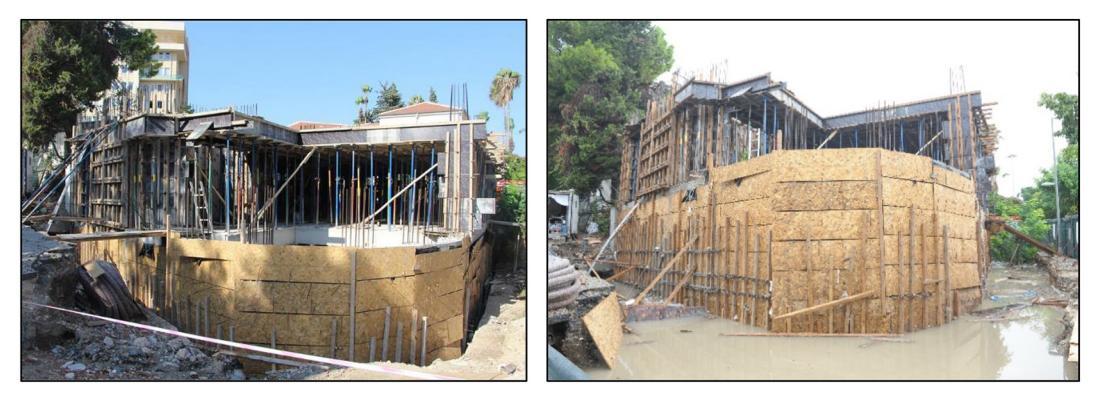
In this study, an office building in Hatay/Turkey which was damaged as a result of the buoyancy force occurred in a flood during construction has been chosen and examined as a case study. As a result of the excessive rain in Antakya city center, it was stated that the office building floated due to the buoyancy force, the foundation moved approximately 3 m upwards from the sub-basement elevation, and when the water receded, the structure was stated to rest in a higher elevation with inclined position, before the rain. The photographs of the structure from the southeast front before and after the floating have been presented in Fig. 3.

Fig. 3. Photographs of the examined structure before and after the floating.
