Engineering Failure Analysis

Erosion process analysis of die-casting inserts for magnesium alloy components

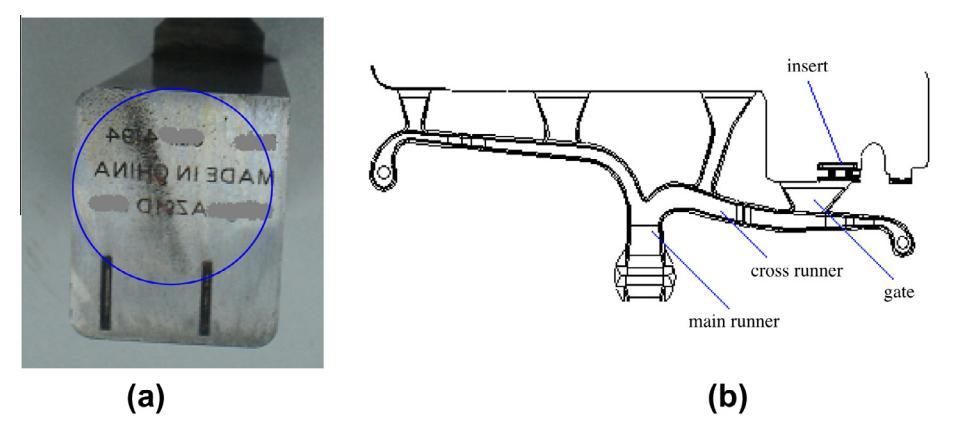
Fig. 1a shows the morphology of eroded insert close to the centre of the gate of the movable die. The dimensions of the eroded surface are 25.9 mm \times 31.6 mm, and the moulding position of the product is shown in Fig. 1b. The insert is located near the gate to deliver molten metal passing through the mould to all sections of the mould cavity. On the surface of the failed insert, a fan-shaped erosion trail with the centre of the gate as the centre of a circle may be observed. Erosion begins beyond a radius of 10 mm and is generally radial in appearance. The degree of erosion varied with the distance from the centre of the gate, and the eroded appearance occurred to badly, then slightly again with increase of the radius.

Fig. 1. (a) surface morphology of the eroded insert, the elliptical shows the corrosive area, and (b) sketch of the insert position corresponding to the product.
