# Back-calculation of failure stress of rockbolts affected by Stress Corrosion Cracking in underground coal mines

D. Vandermaat<sup>a,\*</sup>, S. Saydam<sup>a,\*</sup>, P.C. Hagan<sup>a</sup>, A.G. Crosky<sup>b</sup>

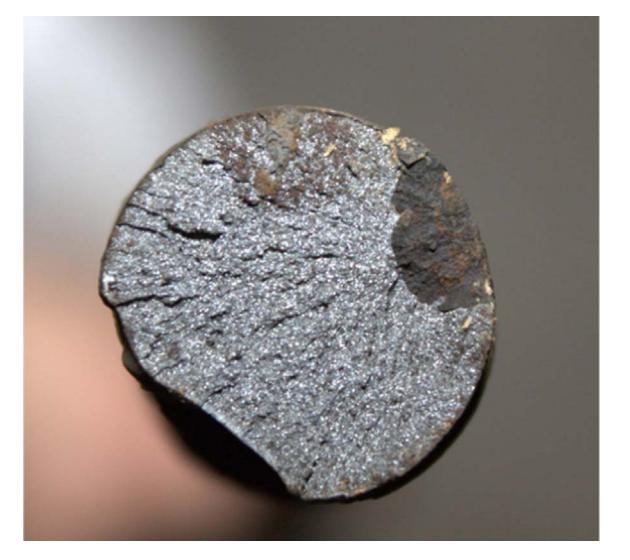
A characteristic SCC failure surface in a rockbolt is presented in Fig. 1. In Fig. 1, the area of crack growth can be seen as the dark thumbnail shaped region in the top-right quadrant of the failure surface. The silver speckled region in the remainder of the rockbolt's fracture surface has occurred by brittle overload once the SCC crack had grown to the critical size. A small amount of material can be seen

missing in the bottom-left quadrant of the rockbolt and is due to secondary corrosion of the specimen.

Fig. 1. Photograph of an SCC failure surface on a rockbolt recovered from an underground coal mine in NSW, Australia.
