## **Engineering Failure Analysis**

## Rapid MIC attack on 2205 duplex stainless steel pipe in a yacht

A duplex stainless steel (2205) pipe in a new yacht suffered an extremely high corrosion rate (40 mm/y) failure. ESEM/EDS and XPS analyses indicate that the failure mode was MIC. The bacteria attached preferentially on the austenite grains forming the colony "centre". The preferential corrosion on the austenite grains formed the "sponge" feature. The remaining ferrite grains became the "skeleton" structure. The sulphate detected by XPS suggests SOB involvement in the MIC. A hypothesis of SRB and SOB proliferating symbiotically proposed in this paper can explain the extremely high corrosion rate. SRB transferred sulphate from seawater to sulphide. SOB converted the sulphide to the extremely acid (H<sub>2</sub>SO<sub>4</sub>). SOB should be the main culprit of the failure through its high corrosion rate. The nitriding effect around the FZ had been confirmed by SES and EDS analyses. The high nitrogen contents attracted the bacteria to attach and proliferate. This finding may uncover the mystery of why weldments are susceptible to MIC.

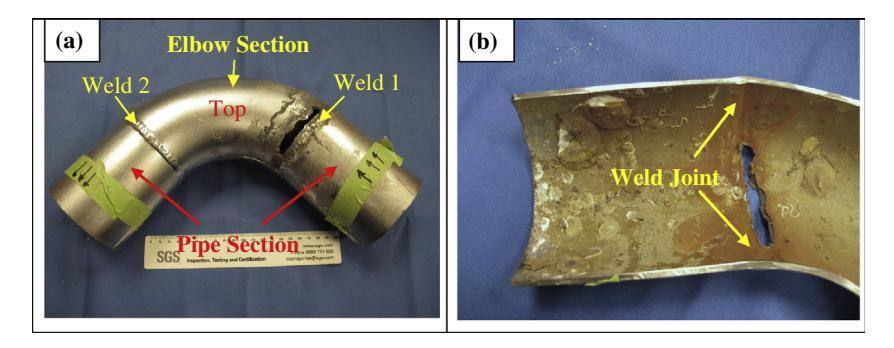
Fig. 1. (a) The pipe coupon from a new yacht with a significant corrosion hole formed in merely 3 months after its launching, (b) the inside surface of the pipe coupon.

It has been recognised for decades that MIC attach weldments preferentially [7,15]. In industrial practice, the author found that MIC is especially prone to attack the stainless steels around the weld. Fig. 1a shows a rapid corrosion on a 3.5 mm thick DSS pipe in a luxury yacht. It is surprising that in merely 3 months after the yacht was launched, a 10 mm  $\times$  60 mm corrosion hole has formed, with average corrosion rate approximately equal to 40 mm/year. For abiotic corrosions through seawater, it is impossible that such extremely high corrosion rate can occur even in plain carbon steels.

The yacht was launched on 1st November 2012 and three months later, a significant corrosion hole appeared on the seawater intake piping system. The seawater intake piping system provided cooling water to the main engine and generators in the vessel. After its launching, the new yacht had spent 90% of its time dockside in Auckland, New Zealand. Whilst it was dockside and idle, the pipe system contained stagnant seawater. The average temperatures of the seawater was 18 °C, and the pipe's ambient temperatures was approximately 25 °C.

In addition to the extremely high corrosion rate, why the MIC occurred only in weld 1, not in weld 2 although both welds had been exposed to the identical seawater conditions (Fig. 1a)? This was an interesting industrial case which worth to be further studied. Due to the complexity of the microorganism's community in the seawater, laboratory culturing cannot simulate the extremely high corrosion rate at present stage. Therefore, the research methods in this paper were limited to material science approaches.
