## **Engineering Failure Analysis**

## Fatigue failure analysis of rotor compressor blades concerning the effect of rotating stall and surge

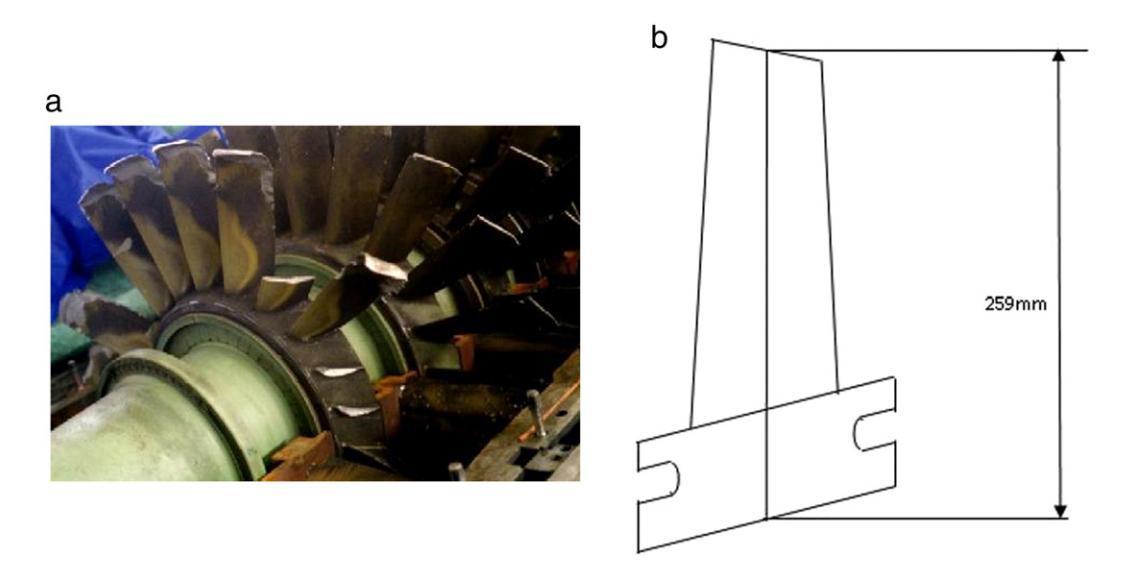
The typical failure of the axial compressor rotor blades is shown in Fig. 1. It can be seen that the failed blades were mostly first stage blades, and the crack was located at or close to the root of the compressor blades. The sketch of the compressor blade is shown in Fig. 1b.

Fig. 1. (a) The images of failed blades; (b) the sketch of compressor blade.
