# The mechanisms of hot salt stress corrosion cracking in titanium alloy Ti-6Al-2Sn-4Zr-6Mo

## Sudha Joseph<sup>a,\*</sup>, Trevor C. Lindley<sup>a</sup>, David Dye<sup>a</sup>, Edward A. Saunders<sup>b</sup>

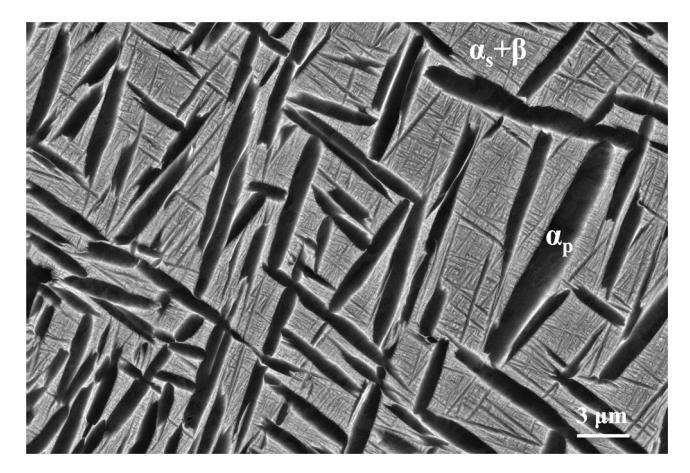
Fig. 2. BSE image showing the typical microstructure of Ti 6246 alloy comprising primary  $\alpha$  and secondary  $\alpha$  within a retained  $\beta$  matrix.

The alloy was  $\beta$  forged, solution treated in  $\alpha + \beta$  phase field, fan air cooled from just below the  $\beta$  transus and then aged at 600 °C. This process gives coarse primary  $\alpha$  ( $\alpha_p$ ) and fine scale secondary  $\alpha$  ( $\alpha_s$ ) in  $\beta$ . The BSE image in Fig. 2 shows the coarse and elongated  $\alpha_p$  as well as much finer  $\alpha_s$  laths residing within a retained  $\beta$  phase matrix.
