Cavitation damage in double-walled mercury target vessel

Takashi Naoe^{*}, Takashi Wakui, Hidetaka Kinoshita, Hiroyuki Kogawa, Katsuhiro Haga, Masahide Harada, Hiroshi Takada, Masatoshi Futakawa

Japan Atomic Energy Agency, Tokai-mura, Naka-gun, Ibaraki 319-1195, Japan

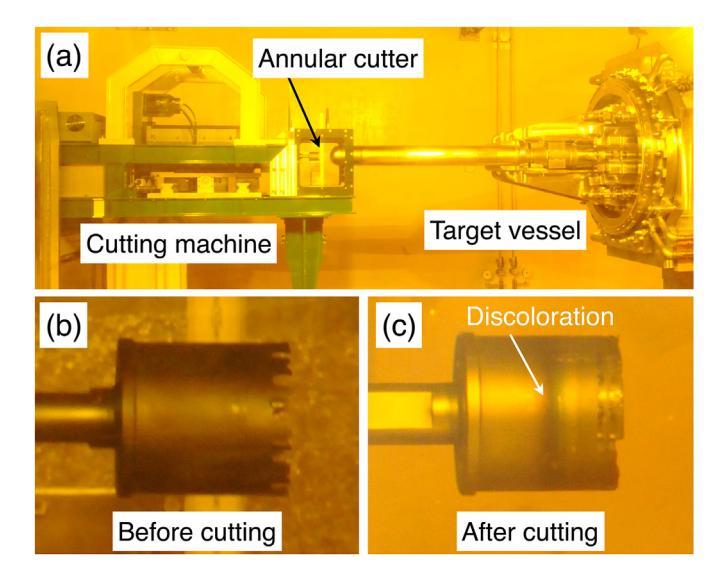
The target beam window was sampled using an annular cutter without any lubricant by using the same procedure as that described in Refs. [6,15]. For target No. 5, it was necessary to cut through four layers of 316L SS to inspect the innermost wall of the mercury vessel. A photograph of target vessel cutting is shown in Fig. 2 (a). Fig. 2 (b) and (c) show photographs of the annular cutter before and after cutting. The cutter teeth broke due to the stress imposed during cutting operation, and heat was generated owing to the cutter body rubbing on the target after the teeth were damaged. Because the replacement cutters continued to break, we stopped sampling of the mercury vessel inner wall.

Fig. 2. Photographs of (a) target vessel cutting machine, annular cutters (b) before and (c) after cutting.

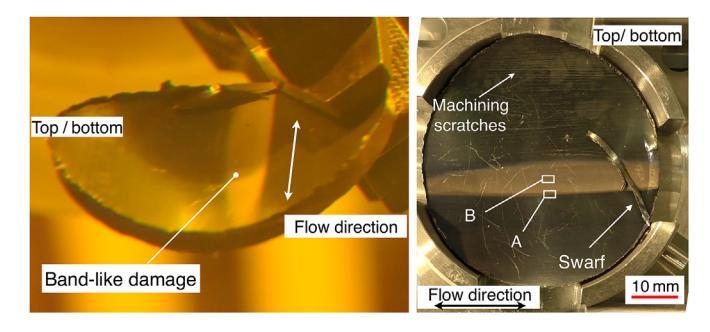
water bath for 60 min to remove mercury and spallation products. No visible damage was observed on the surface of the outer/inner water shrouds facing the water. Fig. 3 shows photographs of the specimen cut from the mercury vessel outer wall. The orientation of target vessel (top/bottom) on the specimen is unknown. The band-like damage occurred parallel to the flow direction. Machining scratches suggesting non-severe damage compared to the damage to the center part are present on the top/bottom side. The inner wall surface observed through the cutting hole is shown in Fig. 4. No visible damage could be observed, except for machining scratches on the surface, although surface discoloration was

Fig. 3. Photographs of specimen from mercury vessel outer wall.

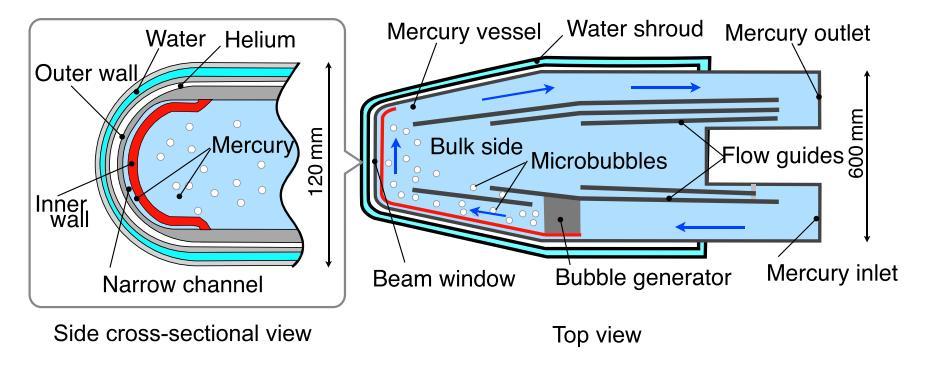
A schematic drawing of the double-walled mercury target vessel is shown in Fig. 1. The beam window of the target vessel is composed of a double-walled (inner/outer wall) mercury vessel and a double-walled water shroud. The thickness of the mercury vessel inner wall is 5 mm and that of the other walls is 3 mm. The gap of the narrow channel is set to 2 mm to achieve a mercury flow velocity of approximately 4.0 m/s. The gap width used in the target was based on the results of off-beam cavitation damage experiments in stagnant mercury, which demonstrated that a narrower gap is likely to reduce cavitation damage because the direction of ejection of the micro-jet changes due to the interference of the wall boundary [14].

Fig. 1. Schematic of double-walled mercury target vessel at J-PARC with gas microbubble generator. (Target No. 5).
