Mechanism for welding liquation cracking in a boron containing 9% Cr martensitic stainless steel

Kejian Li^a, Yao Wu^b, Yifei Li^a, Zhipeng Cai^{a,c,d,*}

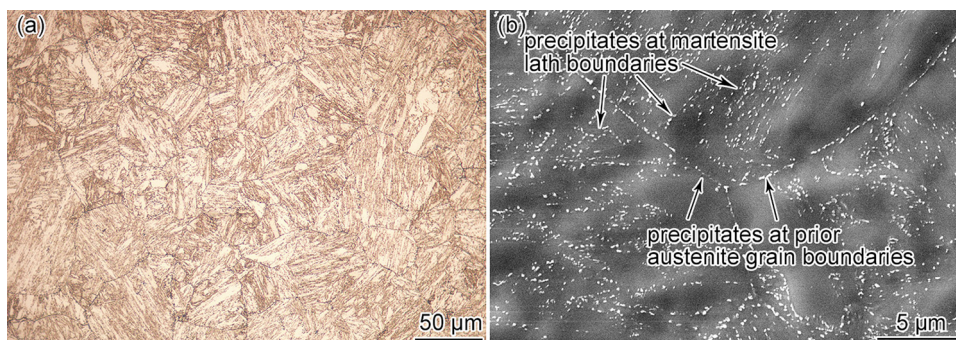
Microstructure of COST FB2 steel in as received condition was characterized by optical microscope (OM) and SEM. It is obvious that in as received condition microstructure of COST FB2 steel is tempered martensite, as shown in Fig. 1. A large number of precipitates (mainly $M_{23}C_6$ type [16]) decorate prior austenite grain boundaries (PAGBs) and martensite lath boundaries, as shown in Fig. 1b.

Fig. 1. Microstructure of COST FB2 steel in as received condition observed by (a) OM and (b) SEM.
