● *Technical Note*

BLINDED COMPARISON BETWEEN AN IN-AIR REVERBERATION METHOD AND AN ELECTRONIC PROBE TESTER IN THE DETECTION OF ULTRASOUND PROBE FAULTS

NICHOLAS J. DUDLEY^{*†} and DARREN J. WOOLLEY[†]

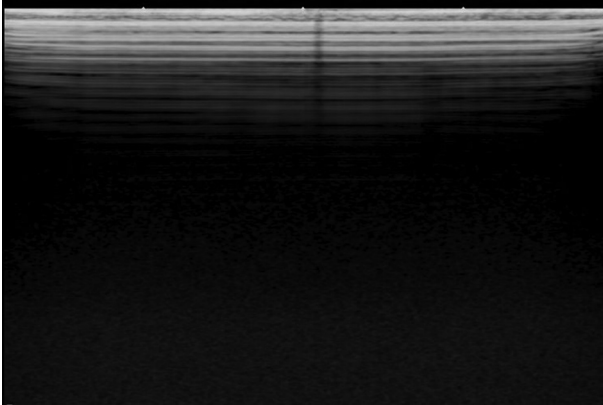
Fig. 1. Central dropout caused by a single element failure. The reverberation pattern also reveals signs of lens wear toward the ends of the array, indicated by reduced separation and intensity of reverberations.

Our experience using the FirstCall and comparing results with the in-air reverberation pattern is that the latter can detect a single non-functioning element, with appropriate adjustment of scanner settings. Figure 1 illustrates dropout caused by a single element failure. The “paperclip test” (Goldstein et al. 1989) and imaging of a TMTO may then be used to assess the severity and inform management of faults; for example, the paperclip test may or may not confirm element failure and a TMTO image may or may not reveal shadowing, but the physical origin of the fault may not be important unless considering a repair.
