Fractographic Analysis of a Split Tooth Presenting Radiographically as a Horizontal Root Fracture in an Unrestored Mandibular Second Molar

Case Report/Clinical Techniques

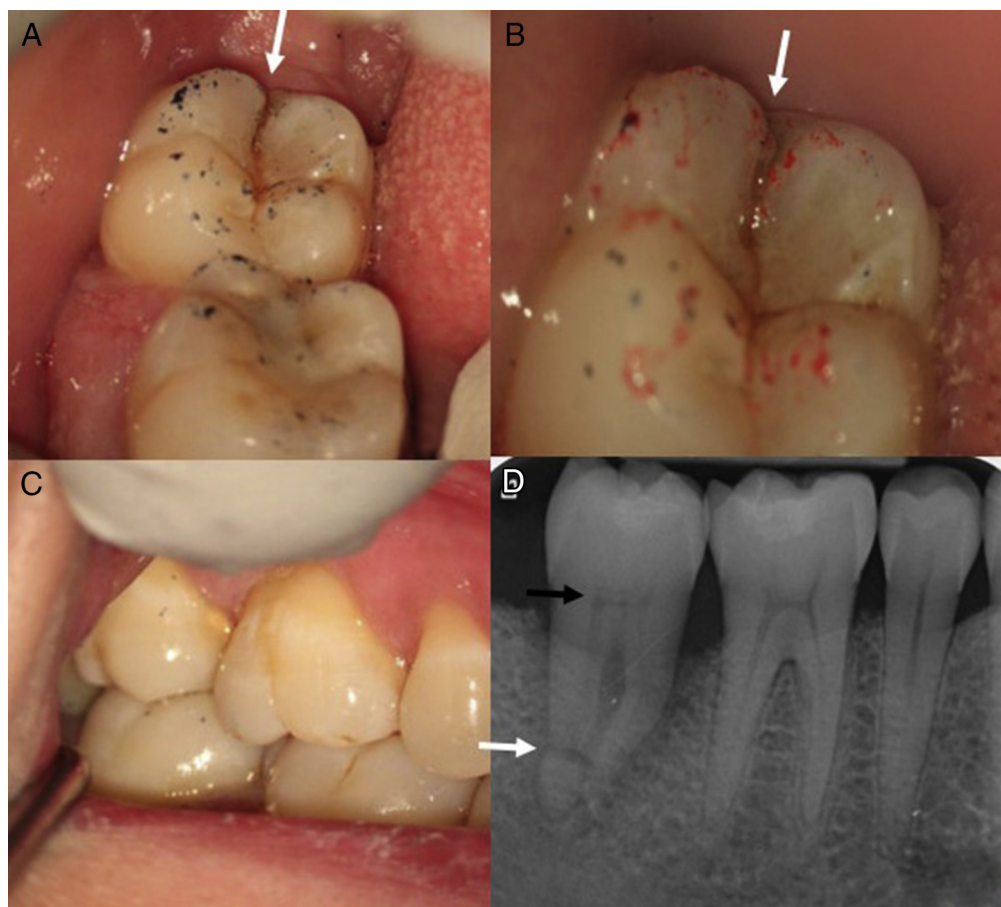
ridging, or tongue scalloping. An intraoral examination under a surgical operating microscope (OPMI pico; Carl Zeiss, Oberkochen, Germany) revealed that an unrestored right mandibular second molar was split mesiodistally and that the tooth fragments could be minimally displaced with digital pressure. This tooth was unresponsive to thermal and electric pulp sensibility tests and was tender on palpation. A 6-mm probing depth was present on the mesiobuccal aspect. No draining sinus tract was evident. Marked wear facets were present on the right mandibular first molar. Intraoral periapical radiography (VistaScan; Durr Dental, Bietigheim-Bissingen, Germany) revealed a partially obliterated pulp chamber, crestal bone loss, and a radiolucency apicocrestally surrounding the mesial root of the second molar. The apical third of the distal root appeared to be horizontally fractured (Fig. 1A–D).

Figure 1. (A) Clinical presentation of a mandibular right second molar (31) with a stained distal fissure (arrow) and blue marks indicating centric contacts. (B) A magnified view of 31. Note the fracture extending over the distal marginal ridge (arrow) and the red marks indicating working and nonworking contacts. There is evidence of occlusal surface wear on the steep portions of the distal margins. (C) A right buccal view showing good intercuspation typically seen in cracked teeth. (D) A periapical radiograph showing apparent horizontal root fracture associated with unrestored 31. Note the calcification in the pulp chamber (black arrow) in 31 and marginal bone loss.
