Acta Orthopaedica et Traumatologica Turcica

Fracture of the femoral component after a lightning strike injury: A case report

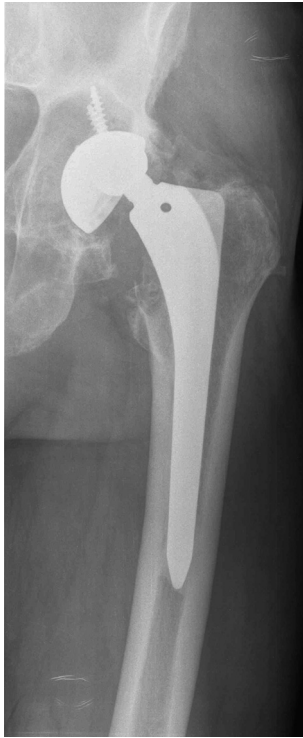
In September 2011 (ten years after primary THA), the patient came to our clinic complaining of hip pain. An important cup asymmetry that indicated wearing of the polyethylene was observed in the radiographic study (Fig. 1). The patient was 185 cm tall and weighed 110 kg (body mass index [BMI], 32.14 kg/m²). The patient underwent revision of the acetabular component and an exchange of the polyethylene component. Significant metallosis and loosening of the acetabular component was observed. The selected components for the revision were a 58 mm Trilogy[®] (Zimmer, Winterthur, Switzerland) acetabular shell attached with three (20, 30 and 35 mm) screws with a Trilogy[®] 58/36 cup. The Bicontact[®] stem was stable, thus no femoral stem revision was performed. This stem system was an uncemented titanium coated stem with a metaphyseal support. A correct fixation without any sign of collapse and anteversion were evaluated previously to the decision of maintaining the component. A Bioball[®] (Merete

Fig. 1. Anteroposterior radiograph showing wearing of the polyethylene.

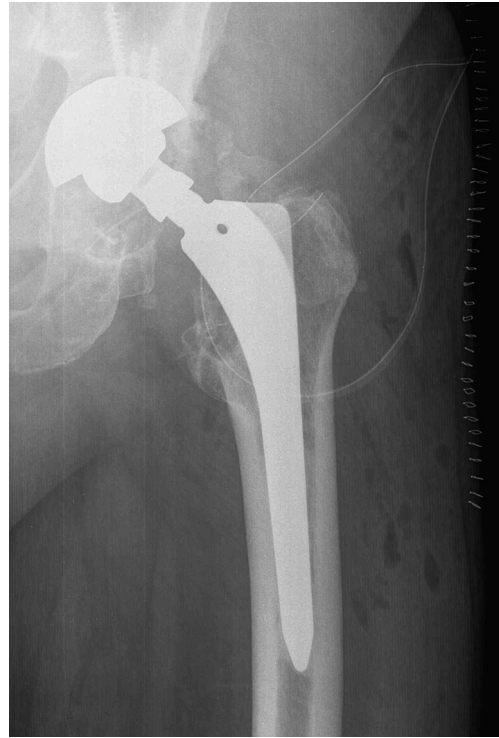
Fig. 2. Postoperative radiograph after first revision. A Bioball 4XL was required.

Medical, Berlin, Germany) with a 4XL neck was required to maintain the correct stability of the prosthesis due to laxity with pivoting and external rotation. The Bioball® system consists of different modular neck adapters which allow the surgeon to correct the length and offset of the neck when required. There are eight different sizes between “S” and “5XL” in ascending order, depending on the gap to correct. This implant could be useful specially in those revisions of either stem or acetabular component. Regarding to the case, the most probable cause of this laxity is the placement of the revision cup which is in a high, neutral and horizontal position (Fig. 2). The patient had a normal and uneventful postoperative period and remained asymptomatic for two years. He had a Merlé d’Aubigné Postel of 6.6.6 and a Harris Score of 94/100 at the last control.

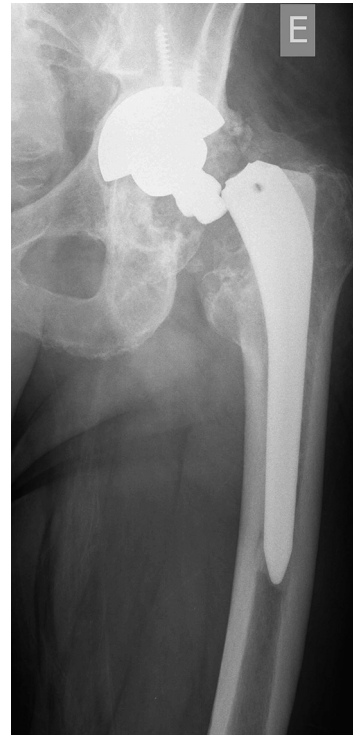
In October 2013 (two years and one month after the revision procedure), the patient was surprised by a storm and was struck by lightning while strolling. He remained conscious and suddenly he was unable to bear weight on the left leg and a deformity on his left lower extremity was detected. His neurovascular status was stable. Plain radiographs demonstrated a displaced fracture through the base of the neck of the femoral component (Fig. 3). The patient underwent revision THA through a posterior iterative approach. A transfemoral osteotomy was required to extract the stem, which presented no signs of loosening. Prophylactic Dall-Miles wiring was done to prevent fractures just under the osteotomy. The selected component for the revision was a modular curve Revitan® (Zimmer, Winterthur, Switzerland) system. It was a 200 × 180 mm stem with a distal locking screw of 36 mm and a metaphysis of 75 mm with 15° of anteversion. The head was a #36 metallic. Finally, the osteotomy was fixed with four Dall-Miles cerclages (Fig. 4). After the surgery, the patient needed two blood transfusions due to postoperative anaemia. The postoperative course was otherwise unremarkable and the patient was allowed partial two-crutch assisted weight-bearing. The patient was discharged with an active range of motion of

Fig. 3. Anteroposterior radiograph after the lightning strike. The fracture locates through the base of the neck.

75° of hip flexion and 15° of hip abduction. Three months after surgery, the radiographs demonstrated consolidation of the osteotomy. After one year, the patient is satisfied, without pain and had returned to work.
