## Analysis of alternatives for using cable bolts as primary support at two low-seam coal mines

Esterhuizen Gabriel S. \*, Tulu Ihsan B.

Office of Mine Safety and Health Research, NIOSH, Pittsburgh, PA 15236, USA

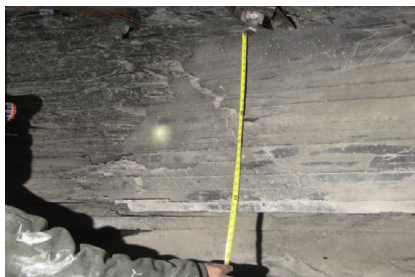
Fig. 1. Laminated silty shale roof rocks observed at Mine B.

The silty shale responsible for difficult ground conditions can be up to 10 m thick and may contain sandstone intrusions. It is overlain by a stronger interbedded sandstone and shale unit. Sandstone is occasionally found close to the coalbed being mined, but typically was found no closer than 2.4 m above the coal bed in the area studied at Mine B. Observations of the rock exposed in roof falls show that it tends to delaminate in thin slabs that are about 25–75 mm thick. Fig. 1 shows the delaminated roof exposed at Mine A and Fig. 2 shows the laminated shale exposed in a roof fall at Mine B.

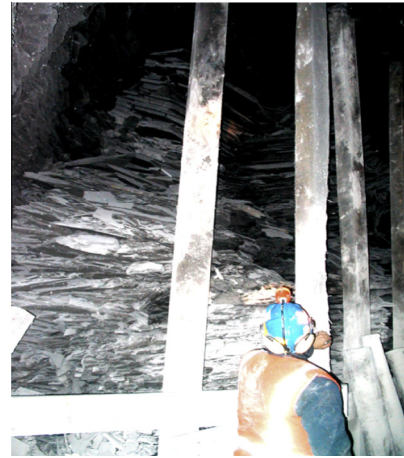
Fig. 2. Large roof fall at Mine A showing laminated nature of the silty shale roof rocks and steep-sided collapse cavity.

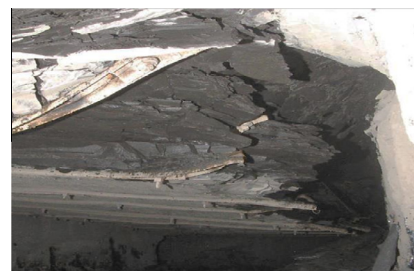
Fig. 3. Severe cutter formation and roof cantilevering at Mine B.

At Mine B, roof control in the areas where the low-strength silty shale is present was generally satisfactory until a 300-m-long roof fall occurred in 2013. The roof also exhibits signs of excessive horizontal stress, with cutters and stress fractures observed. Fig. 3 illustrates the roof damage caused by a cutter that formed well outby the advancing faces at Mine B. The mine layout is adjusted so that the development direction is favorable relative to the major horizontal stress. Prior to the major roof fall, cable bolts were used as part of the primary support system. The large roof fall prompted a change in the mining layout and support system.
