Periprosthetic humeral fractures in shoulder arthroplasty

James M. Gregory, MD, Jason Hsu, MD, and Leesa M. Galatz, MD*

Periprosthetic fractures associated with shoulder arthroplasty are uncommon but can be very difficult to treat. Treatment options depend on the timing of the fracture, the type of fracture, and the stability of the implant. Understanding these characteristics of periprosthetic fractures helps the practicing surgeon to avoid them and also to determine how best to manage them when they do occur.

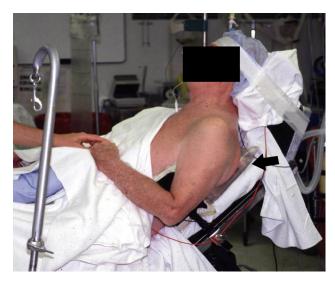
Figure 1 – Appropriate patient positioning includes ensuring that shoulder is positioned off the bed so that the arm is free to extend and externally rotate. In this case, the shoulder pad on the operating table is removable (black arrow). (Color illustration of figure appears online.)

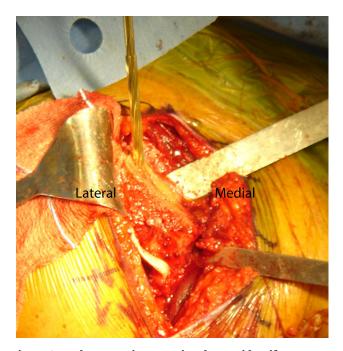
Figure 2 – When reaming, care is taken to identify a start point on the lateral aspect of the humeral head to ensure that the reamer is not introduced in a varus position. (Color illustration of figure appears online.)

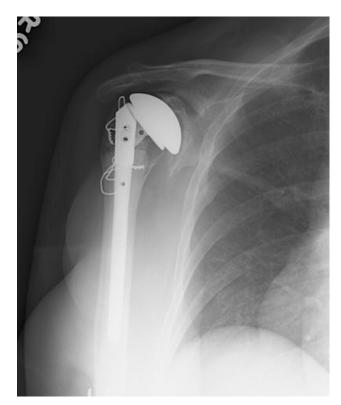
Figure 3 – Anteroposterior radiograph of the right shoulder demonstrates an intra-operative tuberosity fracture that was secured with cerclage wires.
