International Journal of Surgery Case Reports

Spontaneous dissociation of bipolar hip hemiarthroplasty in a patient with nerve palsy: A case report and review of the literature

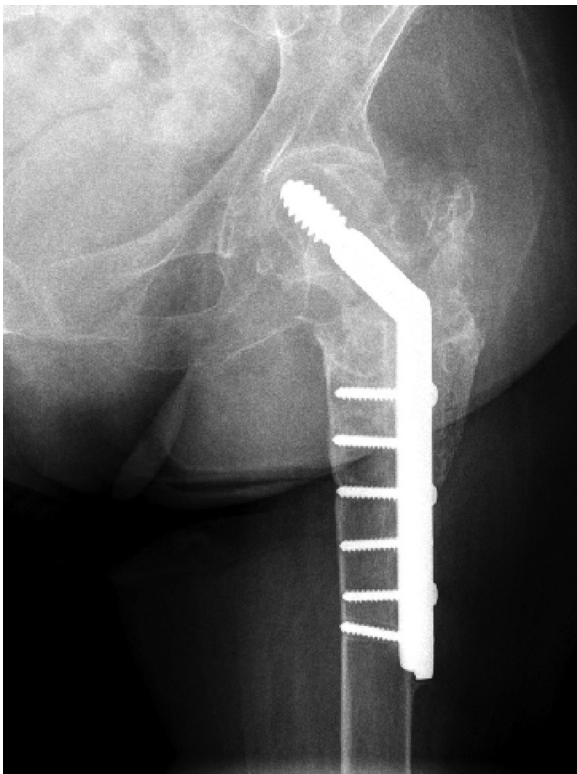
Fig. 1. Plain radiograph shows failure of dynamic hip screw fixation.

A 65-year-old female patient presented with failure of dynamic hip screw fixation for treatment of pathological intertrochanteric fracture of her left hip (Fig. 1). Three years prior to the visit at the clinic, she had pathological intertrochanteric fracture at her left hip from osteomyelitis while she was changing posture from standing to sitting (Fig. 2). She was treated by antibiotic cement spacer and systemic antibiotics. After the infection cleared, she had an operation for dynamic hip screw and bone grafting. At the fifth month of the postoperative period, there were signs of fixation failure. However, the patient refused to have hip replacement after early fixation failure but finally she considered having hip replacement 2 years later. She also had surgery 10 years earlier for spinal stenosis at the lower lumbar spine. After the spine surgery, she developed weakness of her left lower limb. She had no other medical history.

At the clinical visit, the physical examination showed a 6 cm shortening of her left leg compared with the right side. She had left ankle dorsiflexion and toe dorsiflexion motor power grade II and quadriceps motor power grade III. She had decreased sensation over the dorsum of her left foot. A plain radiograph showed loosening of the dynamic hip screw and bone loss in the femoral head.

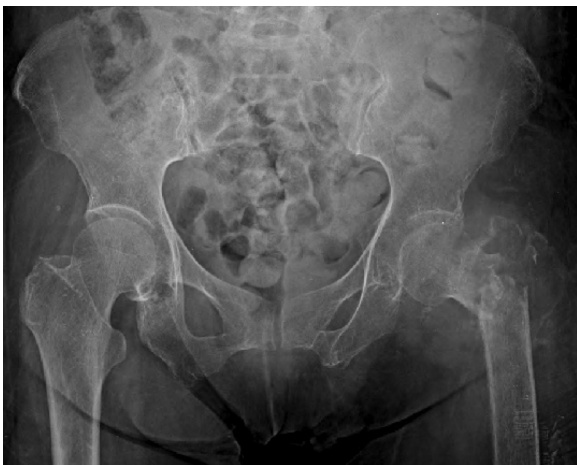
Fig. 2. Initial plain radiograph of fracture.

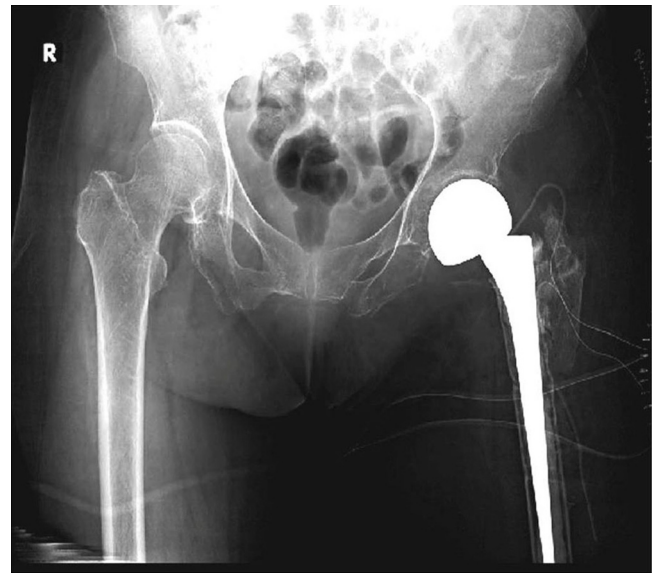
Fig. 3. Immediate postoperative plain radiograph.

The postoperative examination found that the patient still had a shortened left leg of 5 cm compared with the right side (Fig. 3). The patient was allowed to ambulate with a walker by full weight bearing after the operation.

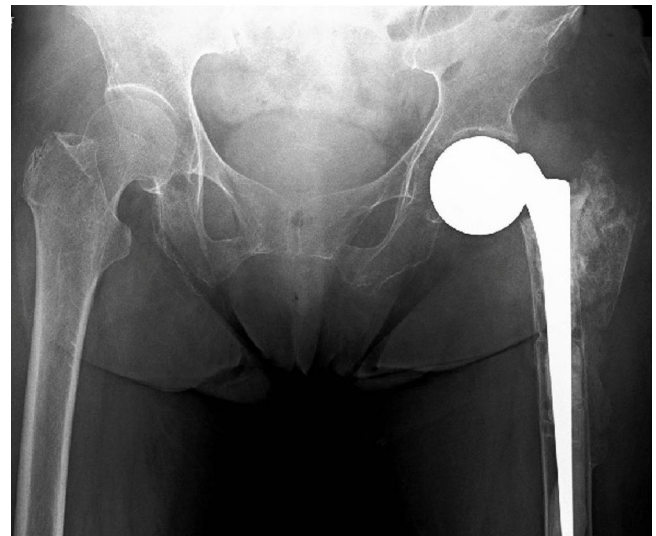
Fig. 4. Six-week follow-up plain radiograph.

hip as usual. She said she didn't use her orthopedic shoe lift and didn't step with full weight on her left foot because she was familiar with non-weight bearing without the shoe lift for a long time. The hip radiographs demonstrated dissociation of the components of the bipolar hemiarthroplasty at the femoral head and neck junction (Fig. 4).

Open reduction was performed through the old surgical scar using the posterior approach. The femoral head component was found intraoperatively in the acetabulum and was covered with a well healed capsule. The tapered part at the inner head and stem neck didn't show any scratch marks or defects. A new femoral head with a longer offset was assembled to the old femoral stem (Fig. 5).
