Flexural strength of weathered granites: Influence of freeze and thaw cycles

Sarkar Noor-E-Khuda ^{a,*}, Faris Albermani ^b, Martin Veidt ^c

The effect of freeze-thaw cycles (FTC) on the flexural strength of granite panels is investigated in this paper. Specimens from three different types of Australian granite were sampled. Fifteen specimens were used as control (unweathered) specimens while another 36 specimens were subjected to accelerated weathering consisting of 100 FTC over a period of 34 days. A controlled freeze-thaw chamber and a temperature range between $-10\text{ }^{\circ}\text{C}$ and $+70\text{ }^{\circ}\text{C}$ was used for this purpose. Ultrasonic pulse velocity (UPV) of the specimens was measured before and after FTC testing. Flexural strength tests were conducted after the FTC were completed. Results showed that thin granite veneers suffered physical degradation accompanied by a noticeable reduction in UPV, density and flexural strength following FTC. Correlation between flexural strength and UPV and between unweathered and weathered UPV is proposed for the three types of Australian granite used in this paper.

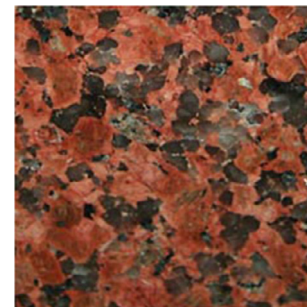
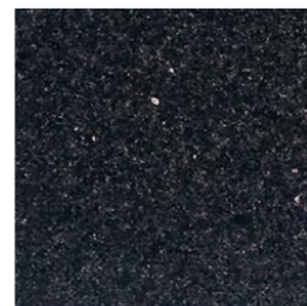
Fig. 1. Granite types (a) Calca; (b) Imperial Black; (c) Grandee.

Three common Australian granite types were considered in this study. These are; Calca, Imperial Black (or Adelaide Black) and Grandee. Calca and Imperial Black stones are quarried in the Eyre Peninsula and Black Hill regions of South Australia while Grandee in the Mullandry district of central New South Wales. These three stone types are characterised by high compressive strength, hardness, durability and visible crystalline structure with interlocking crystals of medium to coarse grain. The three stones are distinguishable by their appearances as shown in Fig. 1; with Calca having pink/red clusters on black appearance, Imperial Black with dark black appearance and Grandee with dark grey appearance. The specimens were prepared from 32 mm granite slabs using laser guided saw.
