# Analytical fragility curves for non-skewed highway bridges in Chile

A. Martínez<sup>a</sup>, M.A. Hube<sup>b,\*</sup>, K.M. Rollins<sup>c</sup>

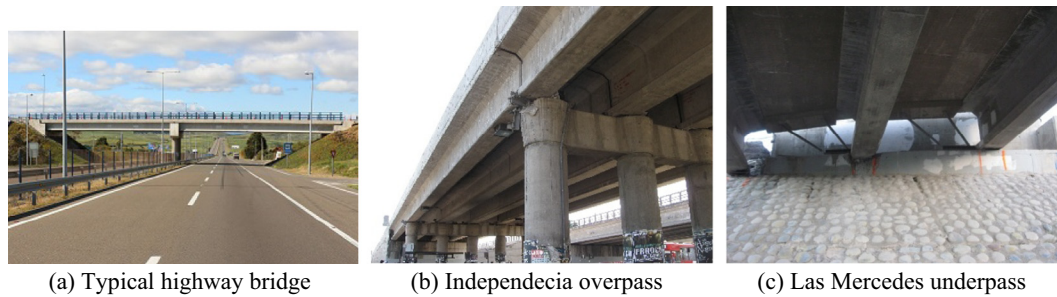
Fig. 1. Typical highway bridges in Chile and observed damage after the 2010 Maule earthquake.

The most common failure in typical highway bridges during 2010 Chile earthquake was the connection damage between the substructure and the superstructure (Fig. 1a), caused by excessive displacement of the superstructure [1–4]. This type of failure is the most likely reason for the low incidence of column damage

The main objective of this study is to obtain fragility curves for typical non-skewed reinforced concrete bridges in Chile (Fig. 1a). The second objective is to quantify the effect of seismic bars, lateral stoppers, and length of the transverse seat width in the seismic behavior of such bridges. To quantify the contribution of seismic bars to the lateral response of bridges, an experimental program was conducted as part of this research. From the results of these tests, a constitutive model is proposed for the lateral response of seismic bars in bridges with and without transverse diaphragms. For the lateral stoppers, a nonlinear constitutive relationship based on a previous experimental program [10] is used.
