Journal of Rock Mechanics and Geotechnical Engineering

Recent advances in high slope reinforcement in China: Case studies

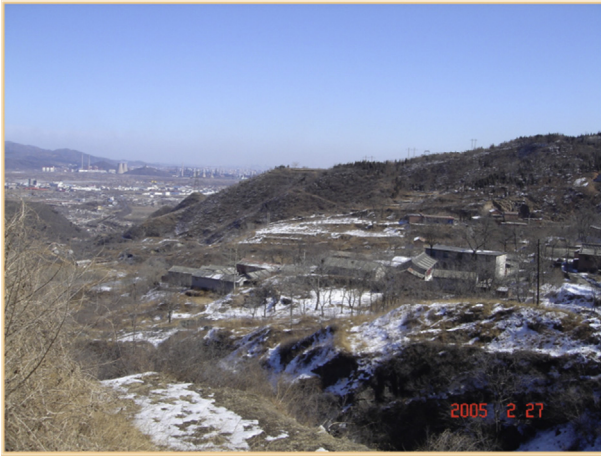
Fig. 1. Landslide in Jietai Temple.

Beijing, which has a history of over 1400 years. The Jietai Ordination Altar in the Temple, a national cultural relic, is the largest Buddhist Temple in China. It confers the highest commandment of Buddhism in history. The ridge of the mountain is 1200 m long from south to north and averagely 450 m wide from west to east. As a result of southward mining by 2 coal dykes at the depths of 122 m and 175 m in recent years, an opening was observed beneath the fourth level of the terrain. After a heavy rainfall on 20 July 2004, a penetrating fractured zone was formed in the temple yard on the ridge. Cracks were also observed in the yard of the temple, resulting in a rapid development of slope deformation, as shown in Fig. 1. Fig. 2 shows the damage of the buildings in Jietai Temple after landslide.

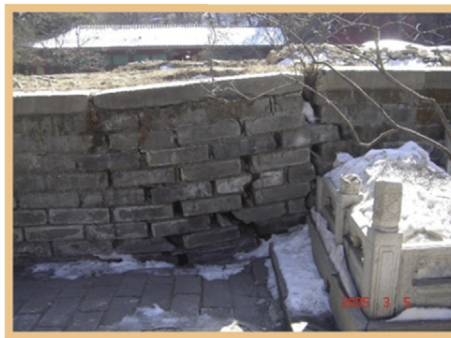
(a) Cracked brick wall.

Fig. 2. Damage in Jietai Temple after landslide.

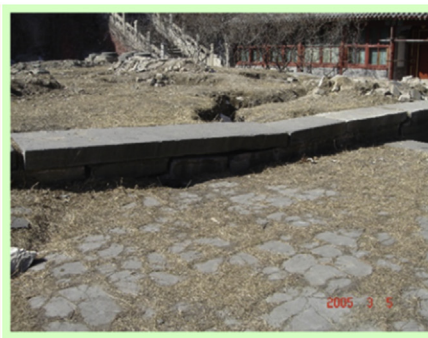
(b) Hallowed ground.

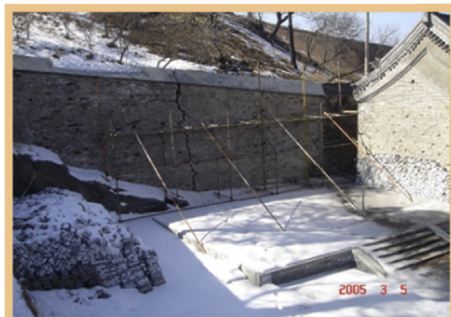
(c) Leaned retaining wall.

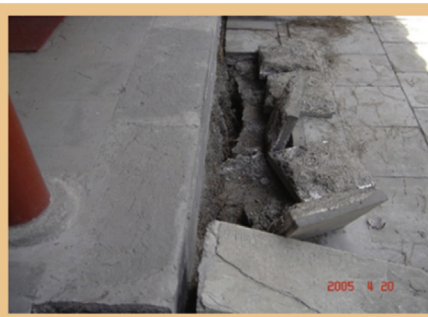
(d) Separated hallway.
