# An experimental study of the damage degrees to ancient building timber caused by lightning strikes

Jingxiao Li <sup>a</sup>, Xiaoqing Zhang <sup>b</sup>, Jing Li <sup>c, \*</sup>, Rujian Li <sup>a</sup>, Muhui Qian <sup>a</sup>, Pingjian Song <sup>a</sup>

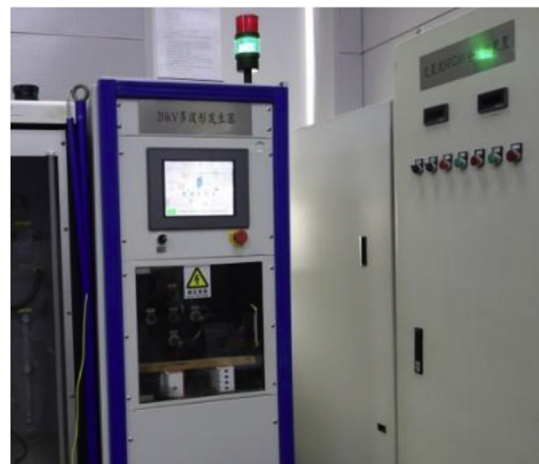
Fig. 1. 20 kV multi-waveform lightning generator.

This experiment was carried out in Beijing Lightning Protection Device Test Center. The equipment included a Chinese GTPS30-20 kV waveform generator (Fig. 1), which was able to produce 10/350  $\mu\text{s}$  of direct lightning current waveform for a maximum of 25 kA. Due to the fact that the lightning which hits timber is not generally the lightning induced wave (in the case of the selected 8/20  $\mu\text{s}$  induced current waveform, the timber surfaces displayed no changes), a 10/350  $\mu\text{s}$  direct lightning current waveform was selected. The electrical generator mainly included a charging device, capacitor unit, controllable trigger discharge device, and control system, of which the control system was primarily composed of a man-machine interface, parameter setting, security protection function, and so on. The screen was able to show the current voltage and charge-discharge state in real time. The digital fluorescent oscilloscope of a lightning current waveform (US Tektronix DPO3054) cannot only precisely display the lightning current peak, wave front time, transfer electric charge, unit energy, and other parameters, but also has the ability to directly store lightning current waveforms. In addition, a video camera was used to record the entire process of the lightning strike, and the camera was adapted to the photographic experimental results. During the experiment, the laboratory altitude was 32.5 m; laboratory temperature was between 26 °C and 28 °C; and the relative humidity was between 42% and 45%.
