Defect-caused alteration of a composite unit modal parameters

This paper presents research on diagnostic parameters for monitoring conditions of a light aircraft engine blade made of composite materials (CM) in flight. This study covers the modal parameters investigation of the blades in the frequency range of 30–60 Hz. Using the Doppler Effect the vibration response between the used blades and a new blade was compared. The used blades demonstrated a fourfold increase in amplitude of resonant vibration in the first bending mode. The amplitude growth of the first bending mode resonant vibration can be used as a diagnostic sign of emerging defects. The ease of amplitude and frequency analysis of a blade resonant vibration in flight conditions will allow researchers to develop an express-control device for technical condition analysis of CM blades while in air.

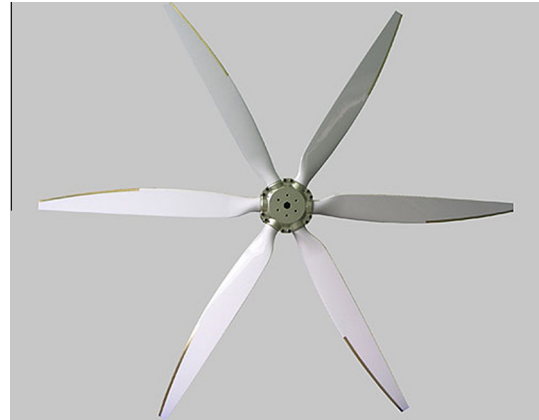
Fig. 1. Propeller of small-engine aircraft.

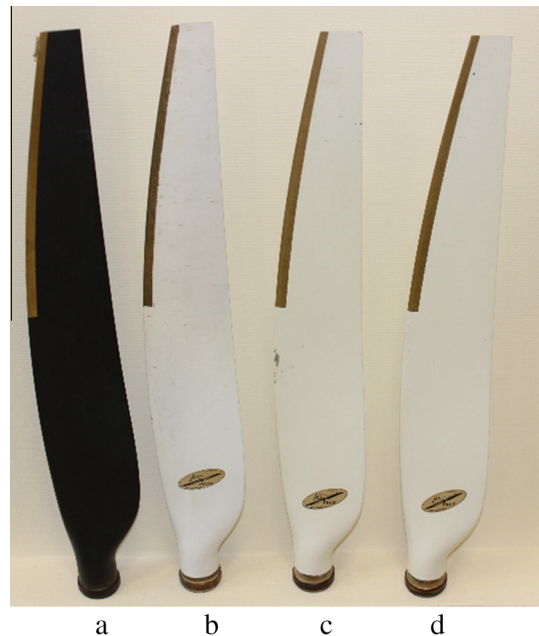
Fig. 2. Blades used during testing.

2. Experiment conditions

than 1.4 times the assigned resource) were examined for the visible defects. In manufacturing composite blades, their weight tolerance can exceed 50 g. This is due to the technological features of manufacturing composite items. The difference in blade mass (represented in Table 2) can lead to blade natural frequency variation up to 2 Hz.
