Structural and Physical Aspects of Construction Engineering

The Effects of Selected Types of Active Bank Stabilization

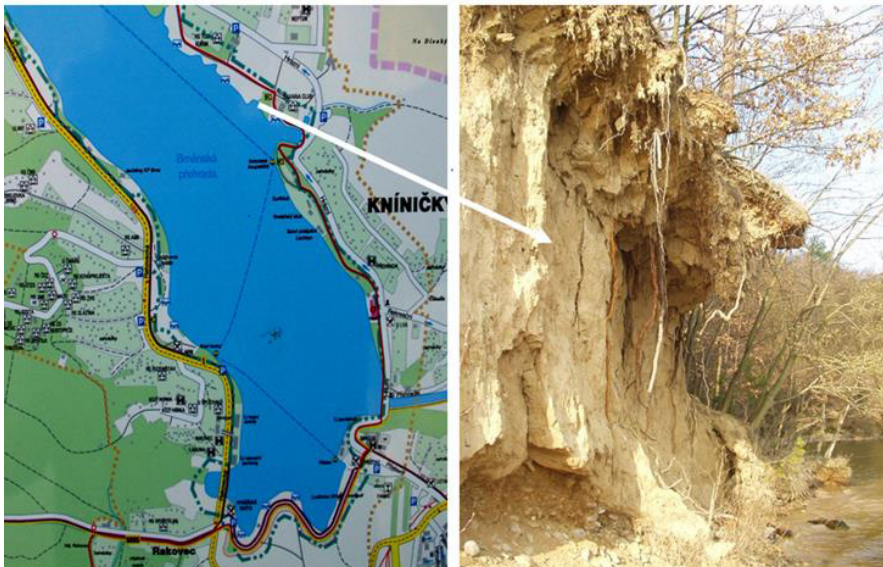
Fig. 1.(a). Brno Reservoir – (b) bank damage.

In the case of the result presentation of projects (project IGA 2016002 and project ÚČ LDF 2016), we draw on a long-term study based on the monitoring of biological stabilization measures at Brno Reservoir. The reservoir is located on the Svratka river, the Czech Republic. The total volume of the reservoir is 21 million m³ and the area of the section called "lake" is about 1 x 3 km (see Fig. 1).
