# Experimental observations on the optimal layout of orientation blocks for safe road crossing by the visually impaired

Tomoyuki Inagaki <sup>a,\*</sup>, Shoichiro Fujisawa <sup>b</sup>, Kazuya Takahashi <sup>c</sup>, Norihiro Ikeda <sup>d</sup>, Kiyohito Takeuchi <sup>d</sup>, Hiroshi Ogino <sup>d</sup>, Satoru Kobayakawa <sup>e</sup>

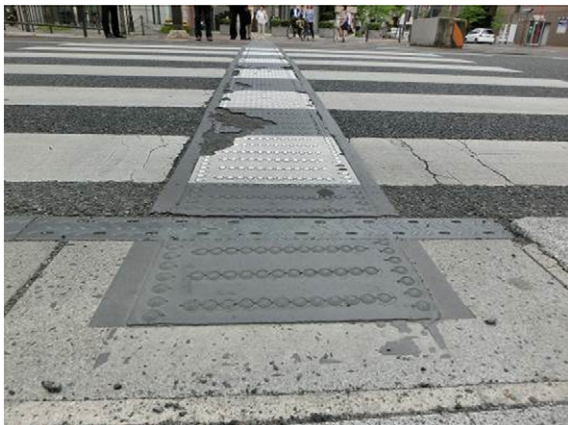
Fig. 1. Example of erosion of protrusions on crosswalk.

The safety of people with visual impairments when crossing has dramatically improved due to the installation of acoustic traffic signals and, in recent years, the proliferation of escort zones, but in addition to such improvements not being available at many crosswalks there are also examples, such as in Fig. 1, where vehicular traffic has eroded the

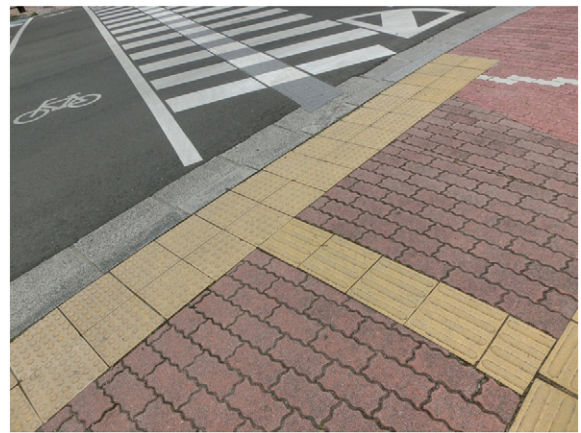
Fig. 2. Example of tactile blocks not perpendicular to the crossing direction.

protrusions to the point where they no longer provide support. In addition, although the *Doro no ido to enkatsuka seibi gaidorain* [Guidelines for Improvements to Facilitate Roadway Mobility] [10] establish the principle that lines of linear blocks (TWSI) at crosswalk approaches are to be positioned such that they indicate the crossing direction, in many cases they are not aligned in the crossing direction or do not connect to the escort zone, breaking the continuity of support (Fig. 2). Furthermore, many people with visual impairments use the difference in level at the curb as a clue to orient themselves at intersection crossing entrances. At intersections where the curb is not aligned perpendicular to the crossing direction, as in Fig. 3, this may not support crossing because people with visual impairments who use the basic “squaring off” technique to orient themselves with the alignment of the curb may veer off in a different direction.
