Optimal glenoid fixation requires cement!

Evan Flatow, MD*, and Victor Olujimi, MD

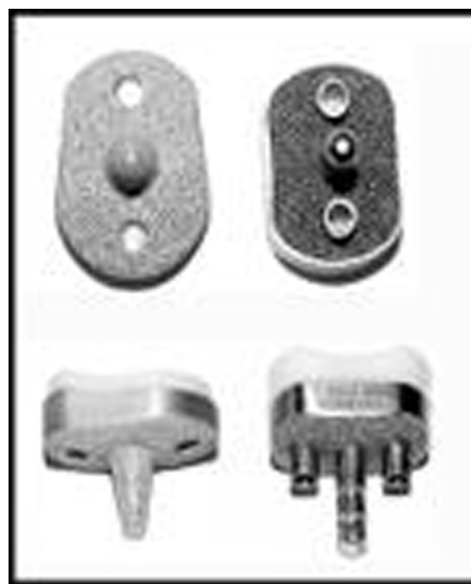
Figure 4 – Metal-backed glenoid.

Metal-backed glenoid components are associated with high revision rates due to accelerated polyethylene wear, glenoid loosening, and bone loss secondary to osteolysis [16,17]. This has been theorized because of the stiffening of the polyethylene when backed by a rigid metal shell. Survivorship was 60% at 10 years and 46% at 12 years with a significant drop 4 years postoperatively. Another complication seen with metal-backed glenoids was polyethylene dissociation from the metal backing (Fig. 4). This was likely secondary to eccentric loading and disengagement of the metal capture. Attempts to avoid this utilized a one-piece molded glenoid component with a less-stiff metal, porous tantalum (Fig. 5). Budge et al. [18] evaluated a one-piece molded polyethylene tantalum glenoid component with an average follow-up of 3.2 years. A 21% failure rate secondary to fracture was observed. Fucentese et al. [19] observed a similar complication and fracture rate with a titanium polyethylene glenoid component. A redesign of the tantalum components has shown good medium-term fixation but longer follow-up evidence is lacking [20–22].
