#### Construction and Building Materials 186 (2018) 652-659

# Grouting performance improvement for natural hydraulic lime-based grout via incorporating silica fume and silicon-acrylic latex

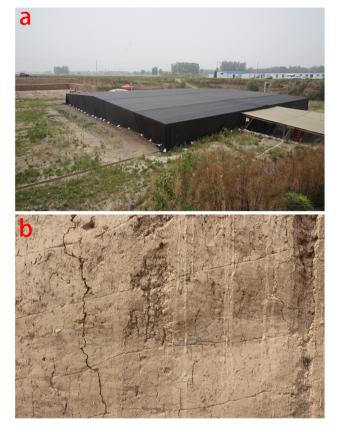
**Fig. 1.** The earthen site to be protected, a: overall view of mausoleum of the king of Dingtao; b: typical cracking disease on the tomb wall.

The research background of this paper was based on the crack grouting intervention in a rammed earthen site (Fig. 1). The mausoleum of the king of Dingtao in Shandong Province is the largest in scale, and is most well-preserved with unique structure among Huangchangticou tombs during the Western Han Dynasty period which have been excavated. It has very high archaeological research and exhibition value. However, after its excavation, there were different forms of diseases such as surface weathering, salt erosion and cracking on the rammed tomb wall and the rammed soil area. Fig. 1b shows the typical cracking on the rammed tomb
