Seismic vulnerability enhancement of medieval and masonry bell towers externally prestressed with unbonded smart tendons

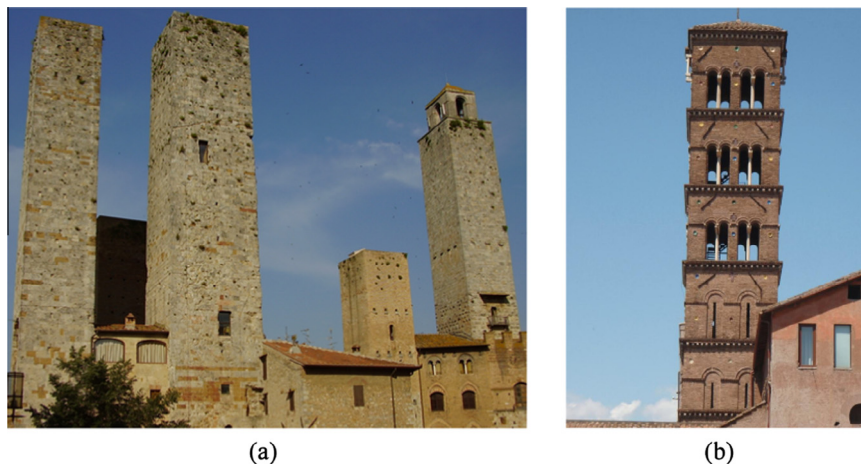
Fig. 1. Typical historical masonry towers in Italy; (a) medieval tower and (b) bell tower.

Historical masonry towers were built either isolated or commonly included in different manners into the urban context, such as built as part of churches, castles, municipal buildings and city walls. Bell and clock masonry towers (see Fig. 1), also named civic towers, were built quite tall and with large belfries for informing people about time and extraordinary events such as civil defence, fire alarm and social meetings. Another reason that led to the construction of tall civic towers in the medieval cities of Italy was that they were seen as a symbol of richness and power of the great families. On the other hand, medieval towers were built quite high but with almost no openings mainly for warlike purposes. Strong damage or complete loss suffered by the cultural patrimony due to EQs has occurred through the history of humanity. The occurrence of these unexpected and unavoidable events has demonstrated that towers are one of the most vulnerable structural types to suffer strong damage as shown in Fig. 2. Their protection is a topic of great concern among the scientific community. Although recent progress in technology, seismology and EQ engineering, the preservation of these quasi-brittle and massive monuments stills represents a major challenge. Masonry towers in all their uses are highly vulnerable to suffer strong EQ damage, even when subjected to seismic events of low to moderate intensity.
