Case Report

Unusually extensive head trauma in a hydraulic elevator accident: Post-mortem MSCT findings, autopsy results and scene reconstruction

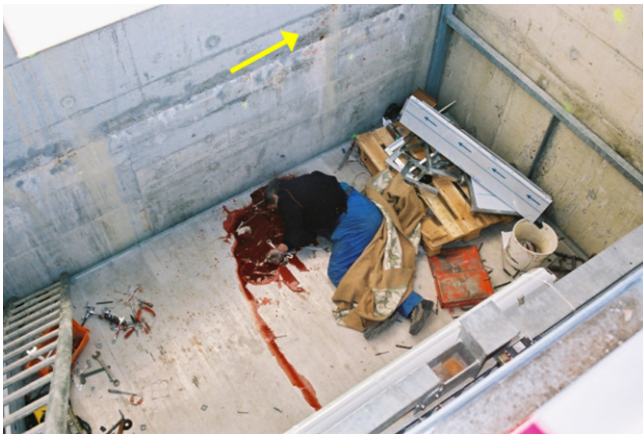
Fig. 1. The scene with the victim lying on the elevator platform in a pool of blood. The arrow indicates the smeared blood including downward oriented blood spatters and traces of brain tissue at the back wall of the elevator shaft.

when suddenly the platform dropped from the ground level 3 m downwards to the basement level. The man died at the scene (Fig. 1). The only witness saw him standing upright with both feet on the platform during the fall.

At the scene the victim was lying in a right lateral position across the platform (Fig. 1). There were extensive blood spatters on the platform and the shaft. At the back wall of the shaft, around 1.5 m above the platform level smeared blood with downward oriented blood spatters and traces of brain tissue were observed.

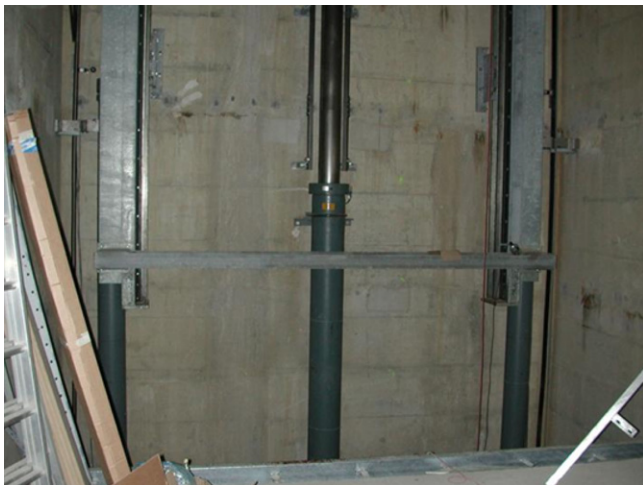
Fig. 2. Photograph demonstrating the electric hydraulics, so called piggyback-system. The middle hydraulic pillar was responsible for transporting the platform to an intermediate stop, where the platform is connected with the two other outside hydraulic pillars by bolts. Subsequently, the outside pillars transported the platform from the intermediate stop to the ground floor.

The elevator was used for transporting goods from the ground to the basement. The platform measured 4×2 m and weighed around 1500 kg. It was moved by electric hydraulics, using the so-called piggyback system (Fig. 2). The middle hydraulic pillar was responsible for transport-

ing the platform to an intermediate stop, which was located 3 m below the ground floor. At this stop the platform became connected with two external hydraulic pillars by bolts and subsequently was transported by the pillars to the ground floor. During construction of the elevator the maintenance worker had to check audibly whether the bolts locked in at the intermediate stop.

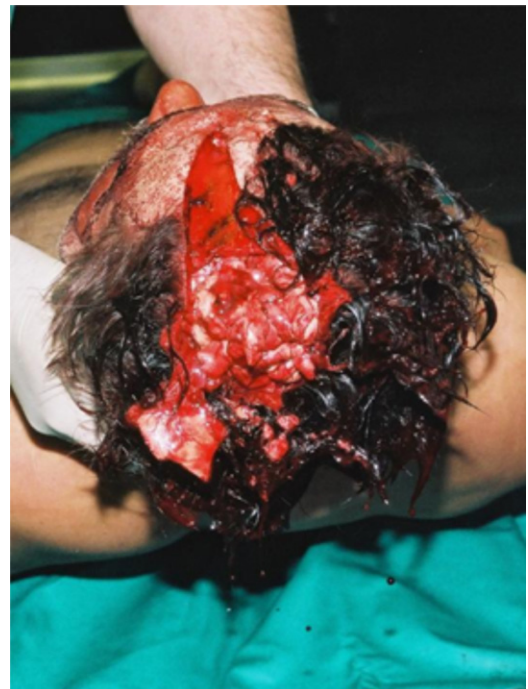
Fig. 3. External inspection of the body shows an open head injury with an extensive galea laceration, skull fracture and severe brain laceration.
