# Repair and structural performance of initially cracked reinforced concrete slabs

Waleed A. Thanoon, M.S. Jaafar \*, M. Razali A. Kadir, J. Noorzaei

Received 29 November 2002; received in revised form 10 September 2004; accepted 28 January 2005

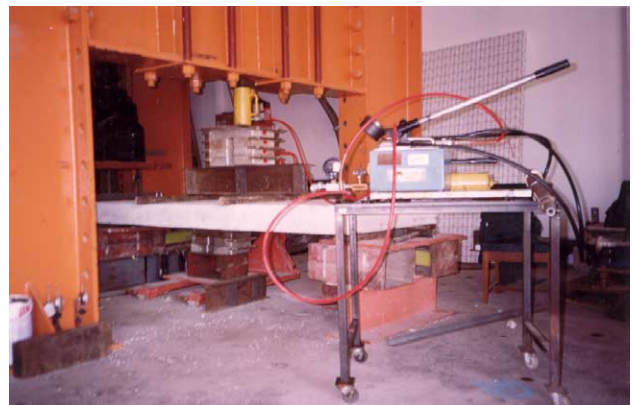
Fig. 1. Test set up.

In order to investigate the effect of various repair techniques on the structural response of one way slab, a total of six full scale one-way reinforced concrete slabs having a dimension of 2.5 m long  $\times$  1.0 m wide and 0.15 m thick are cast, cured and tested. The steel reinforcement consists of five 10 mm diameter high-yield deformed bars with a characteristic strength of 460 N/mm<sup>2</sup>. The 28-day cube compressive strength,  $f_{cu}$  of the concrete used is 30 N/mm<sup>2</sup>. All specimens are tested under two-line load located in the middle third of the slab specimen as shown in Fig. 1. Initially, all slabs are loaded to 2/3 of their expected ultimate load capacity or after the development of cracks in the specimens (initial load ranges between 34 and 40 kN), except for the control slab, which is loaded until failure. Subsequently, the load has been released and the specimens
