Vacuum insulation panels for building application Basic properties, aging mechanisms and service life

Abstract

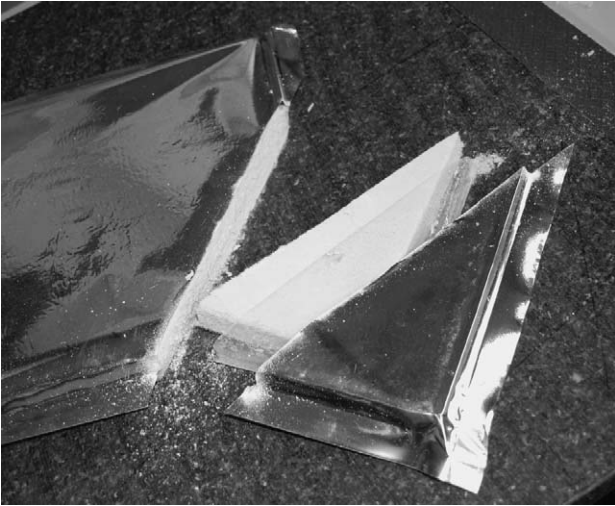
Fig. 1. Section of a VIP. The nano-porous fumed silica material is pressed in a PE fleece and sealed in a three-fold metallized polymer envelope under vacuum (below 1 mbar).

In the last few years a novel type of a thermal insulation board for building envelope application, the so-called vacuum insulation panel (VIP), has been introduced to the construction technology [1]. Since the thermal resistivity for heat flows perpendicular to the main faces is 5–10 times higher compared to a conventional thermal insulation board a new field is opened for slim, energy efficient building envelope design. As an example, insulation of a terrace roof of an apartment building is shown in Fig. 1. A VIP is basically made of a micro-porous core structure which is evacuated and sealed in a thin, virtually gas tight envelope bag (Fig. 2). While open cell polystyrene foam has been used as core material for a long time by the refrigeration industry, fumed silica powder (SiO_2 agglomerates) has become the main core component in VIP for building application. One of the reasons is the less stringent depressurization requirement for this material. Compressed to about 200 kg/m^3 the pore size between the

SiO_2 grains is well below the mean free path of atmospheric gas molecules at internal pressures below 1 mbar. Thus, the molecular collision rate is strongly reduced, and the gaseous heat transfer becomes almost negligible. Heat transfer is limited to solid conduction ($2\text{--}3 \text{ mW m}^{-1} \text{ K}^{-1}$), and thermal radiation (reduced to about $1 \text{ mW m}^{-1} \text{ K}^{-1}$ by admixture of an opacifier). Thus, the total thermal conductivity of the evacuated pyrogenic SiO_2 core is about $4 \text{ mW m}^{-1} \text{ K}^{-1}$. It is evident that the conservation of the initial low pressure and dry state inside a VIP is the main concern when thinking of a long-term application in buildings. A service life of 30, 50 or more years is expected from a built-in component because replacement is often expensive or almost impossible. It is well known that sustainable high barriers can be achieved with metal layers having a thickness of around $10 \mu\text{m}$ or more. In fact, in the first stage of their production, VIPs were produced with laminated aluminum foils of this thickness range. However, thermal resistivity measurements and numerical calculations [2] show that the heat flow through the edge of a metal foil envelope can be even larger than the heat flow through the VIP core material. In order to optimize the opposing requirements of thermal heat loss and gas

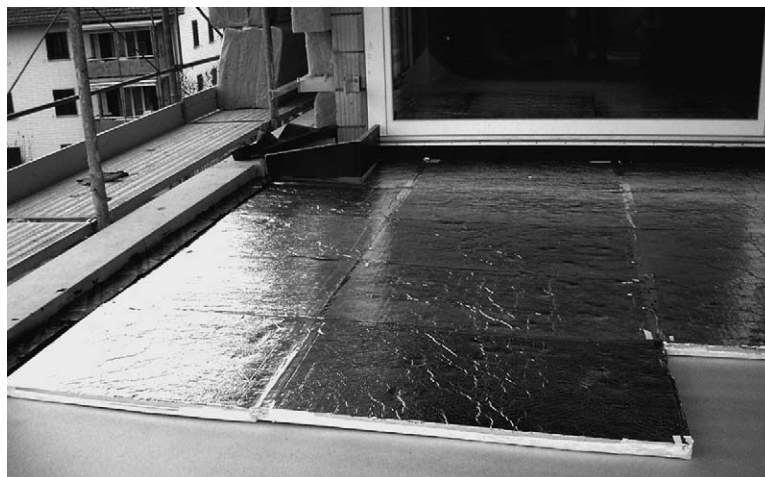
Fig. 2. VIP insulation of a terrace with heated rooms beneath. The panels are placed on a thin polystyrene foam layer for mechanical protection.
