Case Report

Two death cases originating from supplementary heater in the cabins of parked trucks ☆

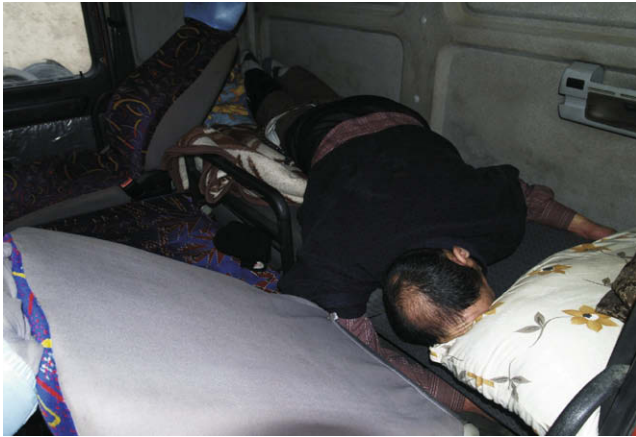
Case 1: The 43-year old male truck driver was found dead in the cabin of a parked truck in an open area (Fig. 1). A dense smell of

Fig. 1. Case 1 was found dead in the cabin.

diesel fuel was detected in the cabin. The supplementary heater has been adjusted to 2.5°/4° for the purpose of giving hot air flowing into the cabin (Figs. 2 and 3). However, cold air was given into the cabin because the supplementary heater was broken. The body of the driver was facedown on the bunk bed. According to witness statements, the driver was waiting for loading in the truck garage and he had attempted to repair the broken supplementary heater the day before.

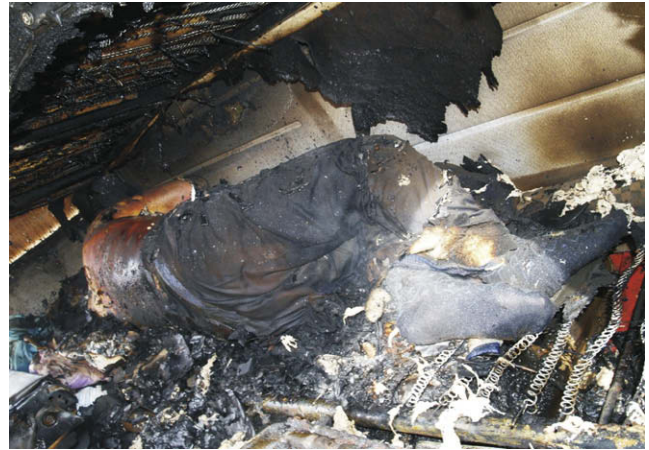
Fig. 4. Case 2 was found dead and burned.

Case 2: A 48-year old male truck driver was found dead due to a fire in a truck parked in an open area of the truck garage (Fig. 4). The fire was started by burning of upholstery cloths and burnable parts of the truck and was caused by operating a supplementary heater at very high temperatures. It was also determined that the supplementary heater in the truck had been installed subsequently under the driver's seat (Figs. 5 and 6). The driver's seat and the one next to it were folded up towards the front of the truck and the body was found lying on the left side on the lower bunk bed, at the back of the cabin.

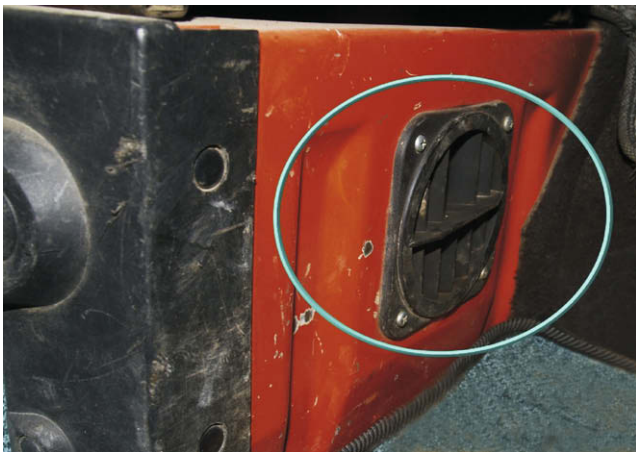
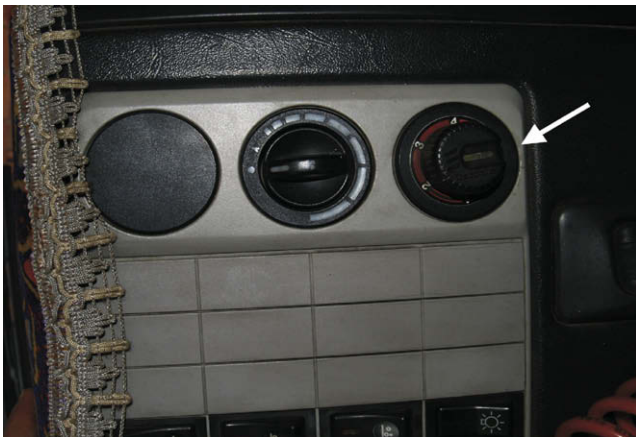
Fig. 2. Supplementary heater of the truck (case 1).

Fig. 3. Supplementary heater was adjusted to 2.5/4 (case 1).
