Legal Medicine

Case Report

Tearing of the left iliac vessels in lumbar surgery revealed by multiphase post-mortem CT-angiography (MPMCTA)

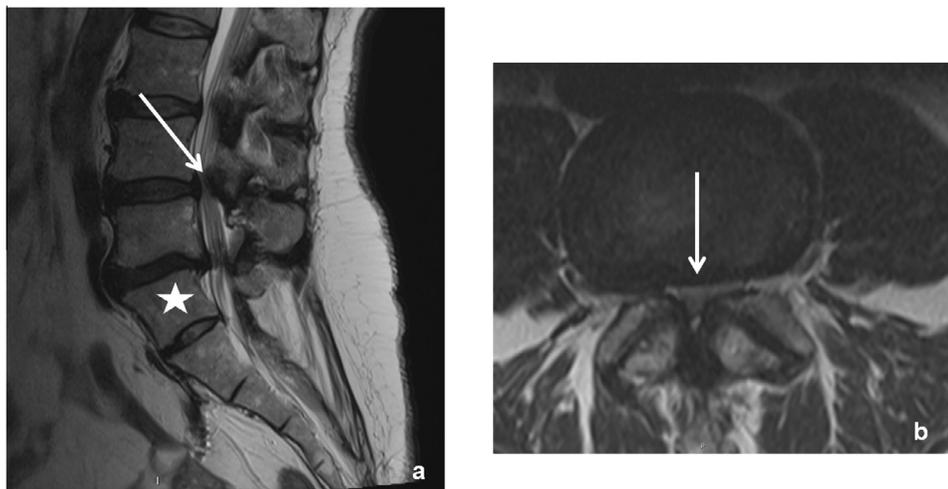
Fig. 1. Magnetic resonance imaging, T2 TSE-weighted images: (a) sagittal and (b) axial acquisitions showing circumferential bulging disc of the L4–L5 level (arrow), posterior interarticular hypertrophic arthrosis, with a narrowed dural sac (acquired lumbar stenosis), and a lumbarization of S1 (star).

A 60-year-old woman was admitted to the neurosurgical unit for symptomatic L5–S1 sciatica with motor deficiency in the extensor muscles of the right hallux, decreased ankle jerk reflex, impaired proprioception of the right foot, and decreased sensitivity of the right hallux and the lateral side of the right foot. She also presented with a right foot drop and a steppage gait. Peripheral pulses were all present. Magnetic resonance imaging showed a narrowed lumbar canal, predominantly in L4–L5, associated with a circumferential bulging of the L4–L5 disc and compression of the right L5 nerve root (Fig. 1). An emergency surgery was decided. The medical records did not mention any bleeding disorder, clotting issue or if the INR (International Normalized Ratio) was checked prior to the intervention.
