# Structural safety of historical buildings made of reinforced concrete, from Banat region – Romania

Marius Mosoarca\*, Gioncu Victor<sup>1</sup>

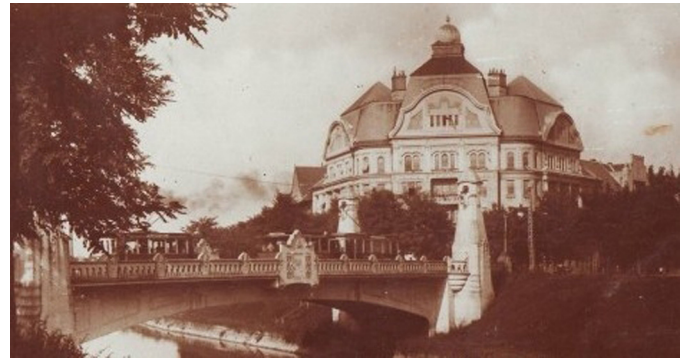
Fig. 3. Decebal bridge in Timișoara.

built in 1909 and it was, at that time, the bridge on reinforced concrete beams with the largest opening in Europe. It has a total length of 58 m with a span of 39 m and a width of 9 m (Fig. 3). Romanian engineer Mihailich Győző designed the bridge. The project obtained its honor diploma, at the International Exhibition, Paris 1910. Today, the bridge is declared a monument and it is fully functional. The structural frame didn't need major consolidations until today, but experimental tests performed on the reinforced concrete beams of similar bridges built in Timișoara have indicated the fact that the reinforcement is severely corroded and as a consequence the reinforcement area is no longer insured.
