Original article

Color characterization of roofing slates from the Iberian Peninsula for restoration purposes

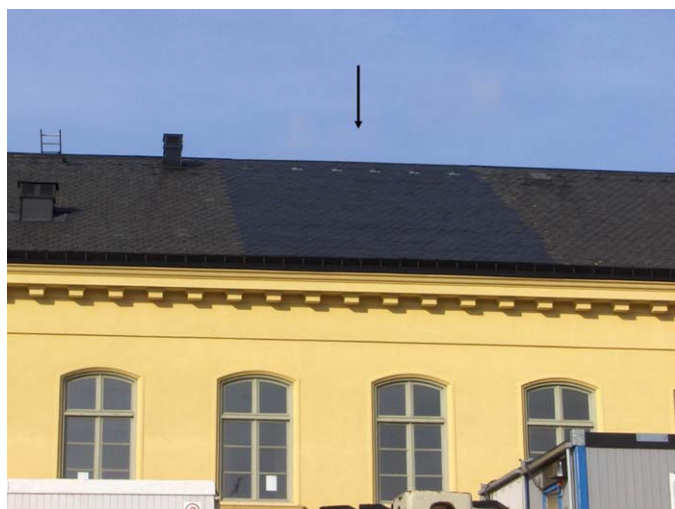
Fig. 1. Example of inadequate partial replacement of roofing slate.
