Case Report

An autopsy case of suction injury

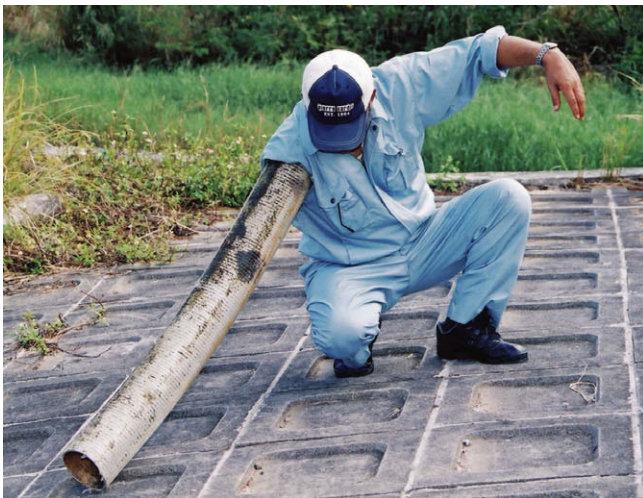
amount of water that drains from the dam is approximately 1600×10^3 kg/day. The duct was made of polyvinyl chloride and had concentric patterns on the surface, and its inner diameter was 20 cm. During an investigation after the accident, a man inserted his upper extremity into the duct, and found that his upper extremity tightly fit in this space (Fig. 2).

Fig. 2. An on-scene investigation. The entire upper extremity of an adult male was trapped so tightly in the duct that it could not be pulled out.

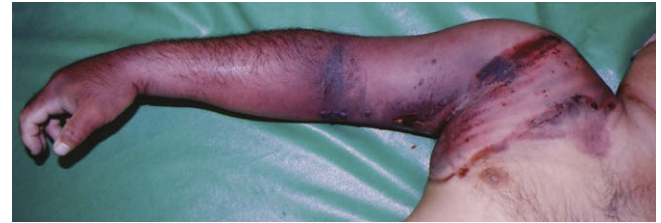
Fig. 3. The right upper extremity showed severe swelling and purplish-red skin. (For interpretation of the references to colour in this figure legend, the reader is referred to the web version of this article.)

An autopsy was performed 22 h after death. The length and weight of the body were 168 cm and 86 kg, respectively. Slight post-mortem hypostasis was observed on the back; no petechiae were observed in the palpebral conjunctivae. The entire right upper extremity was swollen and exhibited purplish-red discolourations (Fig. 3), increased skin tension, and numerous blisters (Fig. 4). A continuous linear abrasion from around the shoulder to the axilla was noted; this abrasion sharply demarcated the injured area from the normal area. Concentric band-like bruises were observed at regular intervals on the skin between the shoulder and upper arm; the pattern of these bruises resembled that of the surface of the duct. The right hand showed gross swelling and was considerably larger than the left hand (Fig. 5). The circumferences

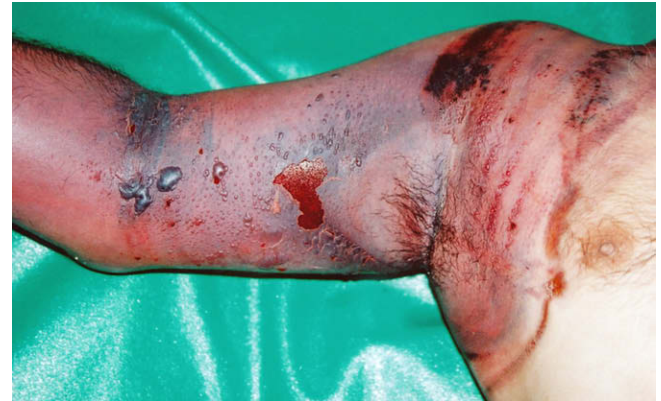
Fig. 4. Concentric band-like bruises were arranged at regular intervals on the shoulder and axilla. There were numerous blisters on the upper arm.

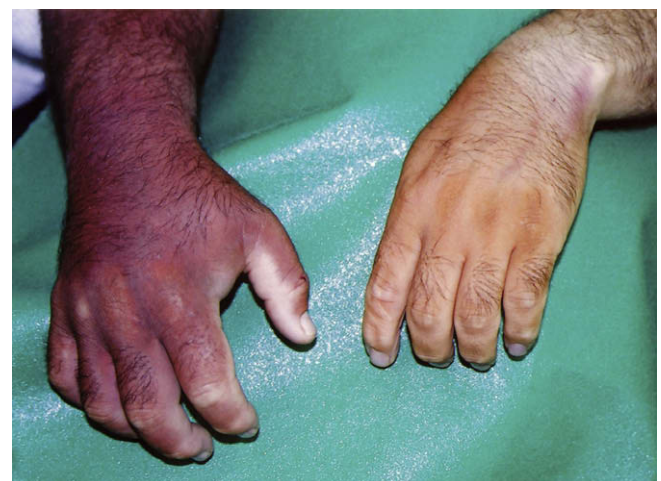
Fig. 5. Both hands of the victim. The right hand is much more enlarged than the left.
