Case Report

Endovascular retrieval of contraceptive implant embolized to pulmonary artery

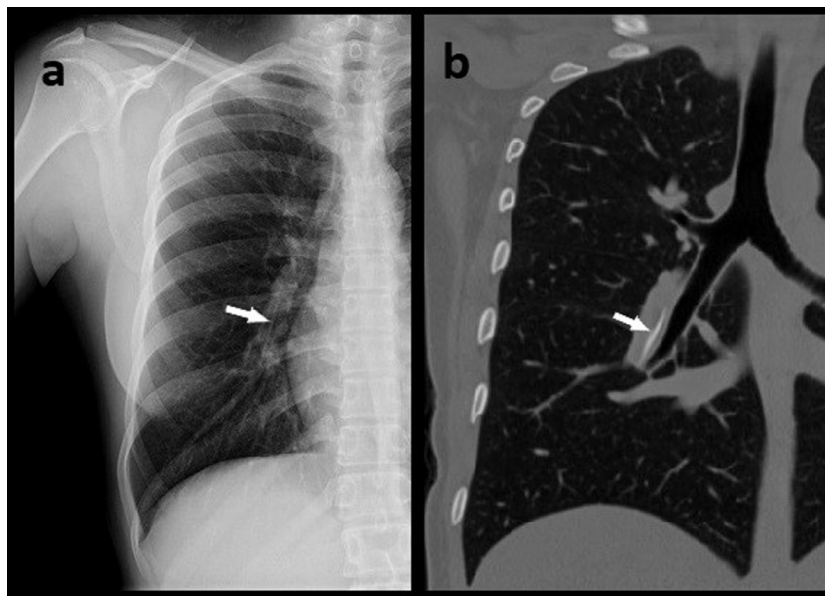
Fig. 1 – Localization of foreign body. (a) Chest radiograph demonstrating a linear opacity (arrow) consistent with an embolized Implanon contraceptive device in the right lower lobar pulmonary artery. (b) Coronal chest CT confirming the presence of a linear foreign body (arrow) within the right lower lobar pulmonary artery.
