# Determination of the causative mechanism of structural distress in the presidential palace of India

The presidential palace of India was constructed between the years 1912 to 1929 CE in a novel architectural style resulting from an amalgamation of Colonial and traditional Indian styles. During a visual inspection of this double-domed structure, meridional cracks were spotted in two out of the four niches in the drum of the lower dome. The observed distress raised two important issues that needed to be resolved- the cause of the cracks and their impact on the structural response. The uncertainty in the actual geometry of the building and the variety of materials used in its construction, the complex layout, lack of prior knowledge of reinforcement details and the undocumented changes made to the structure prompted the adoption of a multi-disciplinary scientific investigation to evaluate the structure. The methodical approach encompassed a literature review of dome failures in the past, historical and geometrical surveys, foundation inspection and the use of relevant non-destructive and minor destructive tests in the evaluation of the superstructure. The information gained from th

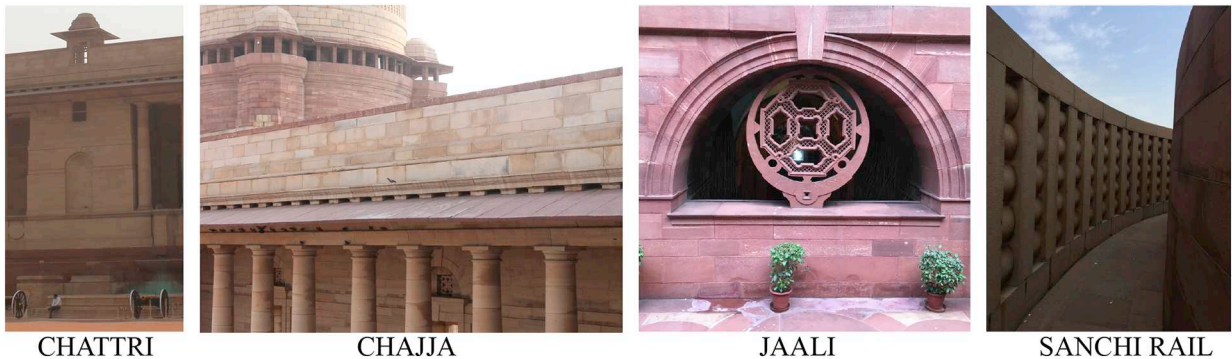
Fig. 2. Traditional Indian architectural elements in the structure- chattri, chajja, jaali and the Sanchi rail (from left to right).

The Rashtrapati Bhavan has been the official home of the President of the Indian Republic since the year 1950, prior to which, it functioned as the Viceroy's house. Edwin Lutyens was appointed as the architect of the Viceroy's house in 1911, when the British moved the administrative capital of India from Kolkata to Delhi. In the early stages of the design, Lutyens conceived the structure in a style he was Au fait with- a classical European building with a high Renaissance dome and Palladian windows. However, he was made to alter the design so as to incorporate traditional Indian architectural elements as well, ergo the high Renaissance dome atop the building was replaced with a flatter Indian dome and elements like the chattri (roof pavilion), chajja (sunshade) and jaali (stone latticework) were added to the structure [1]. A cream-coloured sandstone railing encircles the upper dome lending it a strong resemblance to the stupa at Sanchi. The forecourt of the Rashtrapati Bhavan is seen in Fig. 1. Some of the typical Indian architectural elements used in the structure are shown in Fig. 2. Thus, with the construction of the Viceroy's House, Lutyens invented a new order,
