# Investigation of degradation mechanisms by portable Raman spectroscopy and thermodynamic speciation: The wall painting of Santa María de Lemoniz (Basque Country, North of Spain)

*Department of Analytical Chemistry, University of the Basque Country, P.O. Box. 644, 48080 Bilbao, Spain*

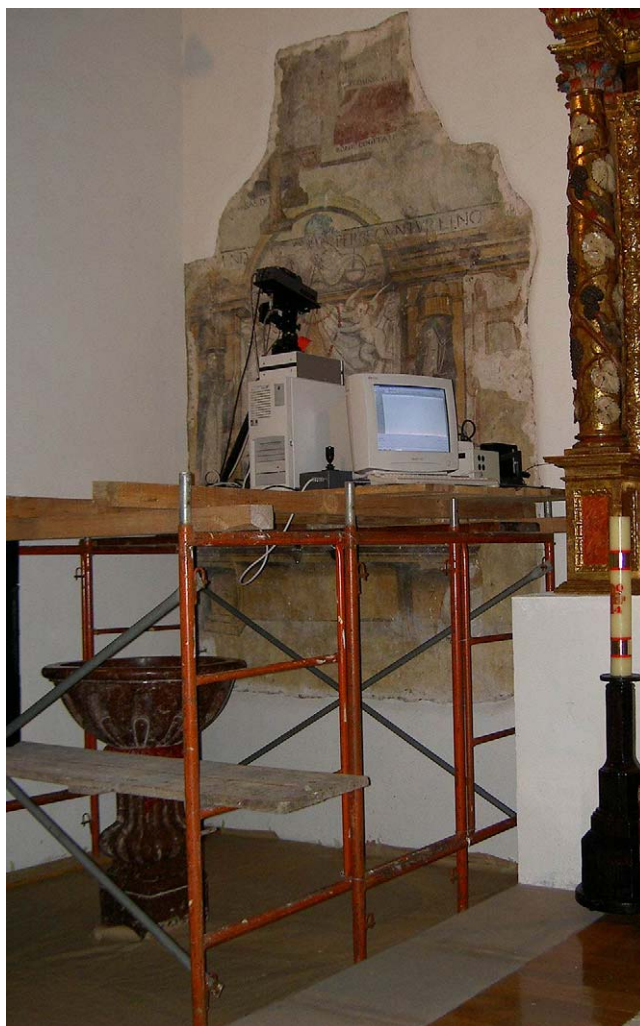
Fig. 1. Experimental set-up with the Raman instrument on the scaffolding.

The device together with the personal computer to control it was placed on top of a scaffolding (see Fig. 1), which made the analysis process more laborious due to the corrective actions taken to avoid the vibrations of the structure. Fig. 2 shows in detail the Raman probe during the analysis. For the proper

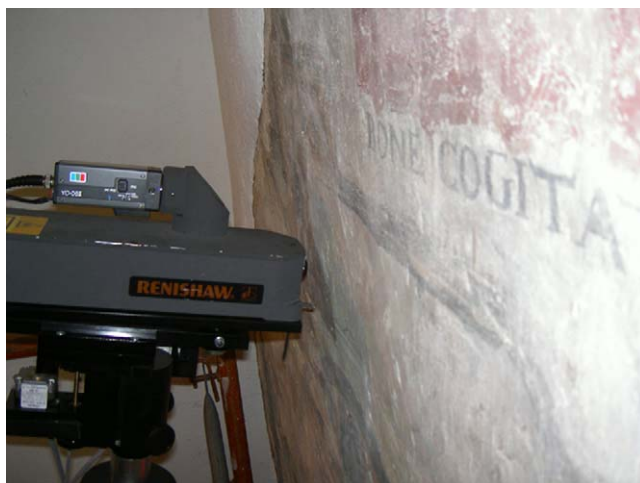
Fig. 2. Detail of the Raman probe at the working distance on the wall painting.
