# Characterization of the main colonizer and biogenic pigments present in the red biofilm from La Galea Fortress sandstone by means of microscopic observations and Raman imaging

Héctor Morillas<sup>a</sup>, Maite Maguregui<sup>b</sup>, Iker Marcaida<sup>a</sup>, Josu Trebolazabala<sup>a</sup>, Isabel Salcedo<sup>c</sup>, Juan Manuel Madariaga<sup>a</sup>

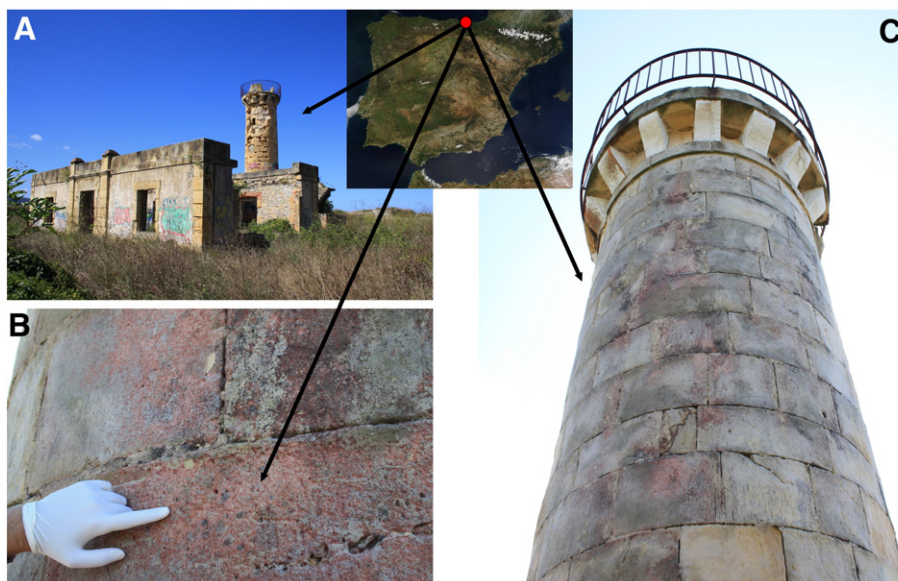
**Fig. 1.** (A) General view of La Galea Fortress, (B) red biofilm colonizing the sandstone from the Northside of the Fortress tower and (C) general view of the Northside of the tower showing the red biofilm on the sandstone blocks.

La Galea Fortress is located in the cliff overlooking the Bay of Agra, in Getxo (north of Spain) and about 80 m above sea level. The Fortress is an 18th century military building and took the place of an old watchtower that already existed in the 16th century (Fig. 1A). It has masonry and ashlar walls, 14 embrasures for cannons (originally they were 18) and it is surrounded by a moat on the land side. The building hosted several storehouses to keep arsenals, as well as installations for the troops. The most important part of the fortress is the principal tower (Fig. 1A, B, C). The tower of the military fortresses was the most important part of this kind of fortifications, where the soldiers observed possible threats. When its military function was discarded at the end of the 19th century, it was used as a lighthouse, until the middle of the 20th century.

The conservation state of the sandstone from the fortress tower is very poor, especially the Southside of the tower (Fig. S1, S2). Alveolization and disintegration phenomena are clearly visible. In some area, certain sandstone blocks are almost disappearing (see details of the disintegration and loosing of the sandstone in Fig. S1, S2). The towerside of the fortress that only shows red biofilms is the north facade. This is the only orientation which shows that sandstone blocks are in a good state of conservation (Fig. 1B, C). In the literature, many authors point out that these kinds of colonizations normally occur facing north and in areas with high moisture content [21]. In this facade, several sandstone fragments with red biofilms were collected. To carry
