Spectrochimica Acta Part A: Molecular and Biomolecular Spectroscopy

A multi-analytical approach for the characterization of wall painting materials on contemporary buildings

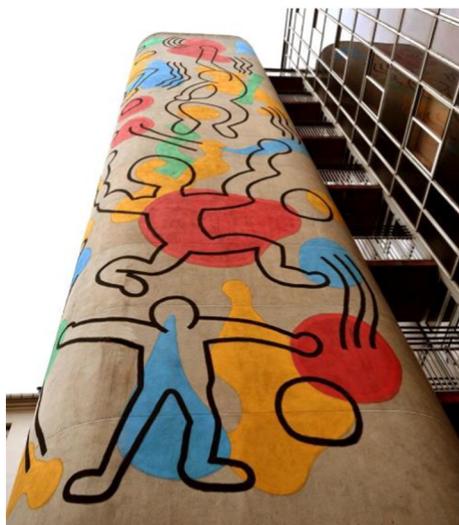
Fig. 1. The Necker Hospital mural in Paris painted by Keith Haring in 1987. Credits: Keith Haring art © Keith Haring Foundation.

The mural painting (Fig. 1) was created in 1987, in typical Haring style, with large areas painted with primary colors and characters outlined with the hallmark black [2].

This monumental work of art was painted on the outer walls of a grey concrete fire exit but due to the weather and the passage of time, the structure is deteriorating. The concrete on which the paint was applied is crumbling and cracking, endangering the work's long-term survival. A number of black lines have deteriorated, and some have sunk into the concrete.
