CUE2015-Applied Energy Symposium and Summit 2015: Low carbon cities and urban energy systems

Power degradation caused by snail trails in urban photovoltaic energy systems

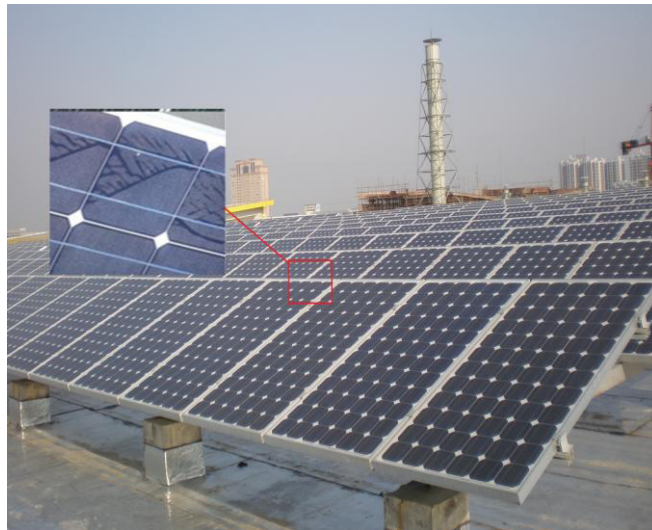
PV modules affected by snail trails in urban photovoltaic energy systems are prepared for study. Figure 1 shows the outdoor scene of urban photovoltaic energy systems affected by snail trails phenomenon.

Fig. 1. Phenomenon of snail trails in urban photovoltaic energy systems
