#### International Journal of Minerals, Metallurgy and Materials Volume 16, Number 2, April 2009, Page 203

# Cavitation erosion behavior of WC coatings on CrNiMo stainless steel by laser alloying

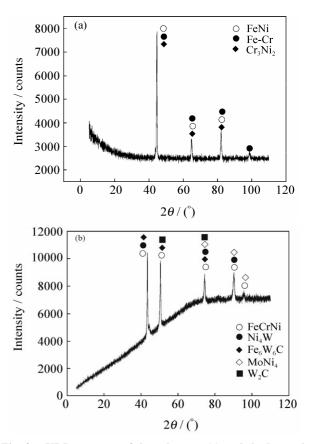
Fig. 3. XRD patterns of the substrate (a) and the laser alloying layer (b).

Fig. 3 shows the XRD patterns of phases in the CrNiMo stainless steel and the laser-alloyed layer. The CrNiMo stainless steel substrate is mainly composed of FeNi and FeCr solid solution (as shown in Fig. 3(a)). After the laser alloying treatment, fine WC powder dissolves into the melt pool, and then solidifies to form different types of metal carbides and tungsten carbides such as  $W_2C$ ,  $Ni_4W$ ,  $MoNi_4$ ,  $Fe_6W_6C$ , *et al.* (as shown in Fig. 3(b)).
