Corrosion monitoring and determination of aluminium fuel clad of Tehran Research Reactor (TRR)

R. Gholizadeh Aghoyeh*, H. Khalafi

Reactor Research Group, Reactors and Accelerators Research and Development School, Nuclear Science and Technology Research Institute (NSTRI), Atomic Energy Organization of Iran (AEOI), Tehran 14399-51113, Iran

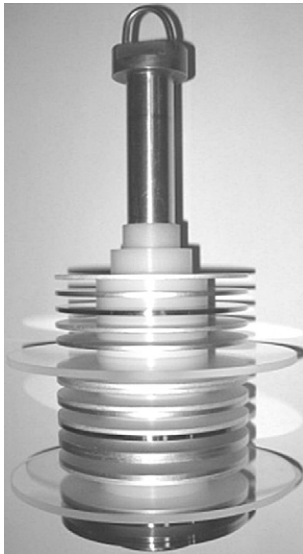
Fig. 1. The TRR corrosion test rack.

3 mm thickness with a central hole designed to fit over the insulated stainless steel rod rack. The nominal compositions of the aluminium alloys and AISI 304 stainless steel are shown in Table 1.

Surface preparation and treatment of the aluminium alloy coupons were identical to that given to Al-clad fuel plates. All of the coupons were machined, polished to semi-bright, identified, degreased and given the same surface treatment (pickling in hot sodium hydroxide solution, cleaning, rinsing, neutralization and drying). Two machined and polished AA-1100 and AA-6061 coupons in rack was rinsed, degreased and pre-oxidized in water at 368.15 K for 24 h. One of the surfaces of these coupons was scratched with a 0.5-mm scribe to simulate a damaged fuel element surface. Polyethylene disks separate the individual coupons and the coupled coupons, one from the other. Two 150-mm acrylic discs were added to avoid contact with the reactor walls (IAEA-Technical Reports Series, 2003). The coupons were assembled in a corrosion rack (see Fig. 1) in the order shown in Table 2.

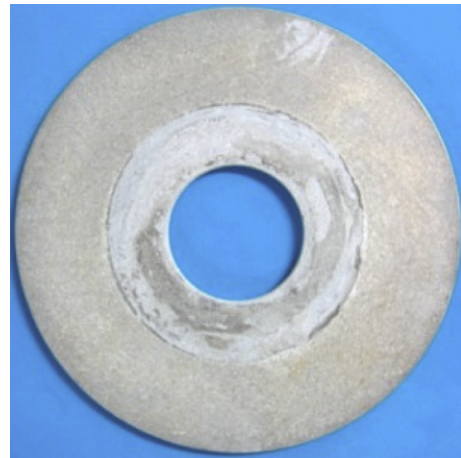
Fig. 3. Outer surface of single 6061 Al alloy coupon after 6 months of exposure in the TRR reactor.
