## Hydroelectric equipment repair

**P**OLYMERIC COMPOSITES have been used in many industries for decades. This article focuses on the advantages of polymeric coatings (efficiency enhancement, corrosion resistance) vs. traditional repair methods.

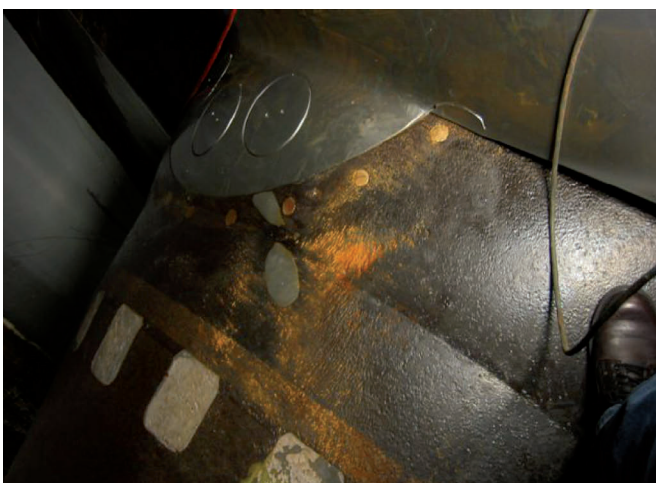
Figure 1. Damage to hub of a Kaplan turbine (L) and close up of the damage (R).

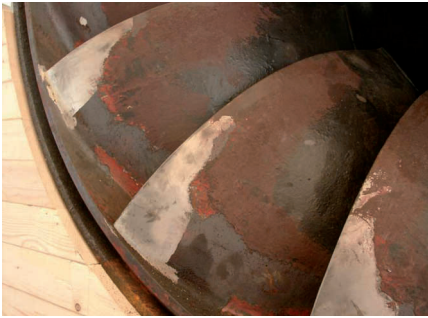
Figure 2. Completed replacement of leading edges damaged by cavitation following extensive repair work.

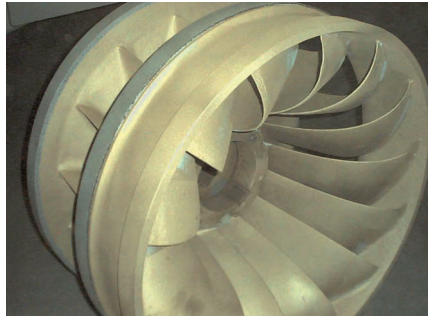
Figure 3. Francis turbine following preparation by grit blasting.

Prior to application, thorough surface preparation is required in the area to be repaired. This is commonly achieved by grit blasting locally to clean and roughen the metal, allowing the polymer to form an intimate bond with the base metal.

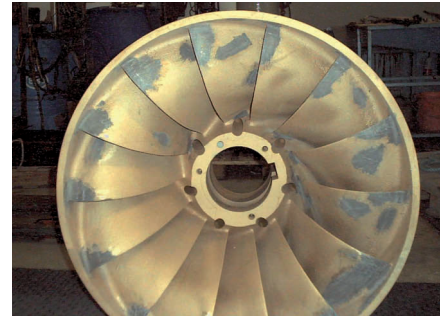
Figure 4. Turbine following rebuild using a paste-grade material to in-fill areas of erosion damage.

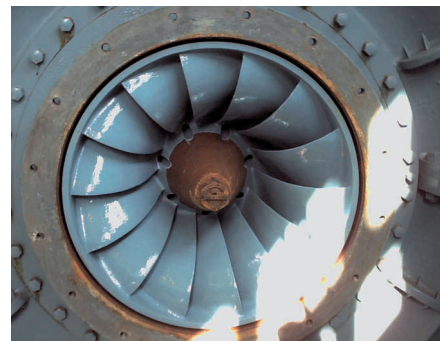
Figure 5. Application of Belzona 1341 (Supermetalglide)<sup>®</sup> in progress to runner. This coating has been proven to reduce surface friction, resulting in higher operating efficiency in fluid flow equipment such as turbines and pumps.

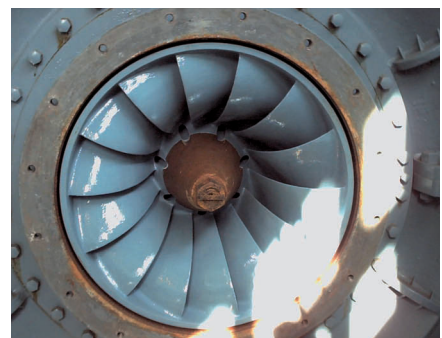
Figure 6. Completed runner installed and ready to return to service.
