Frašťia M., Marčiš M., Kopecký M., Liščák P., Žilka A. (2014). Complex geodetic and photogrammetric monitoring of the Kralovany rock slide. *Journal of Sustainable Mining*, 13(4), 12–16. doi: 10.7424/jsm140403

COMPLEX GEODETIC AND PHOTOGRAMMETRIC MONITORING OF THE KRAĽOVANY ROCK SLIDE

rock slide, laser and image scanning, RPAS photogrammetry

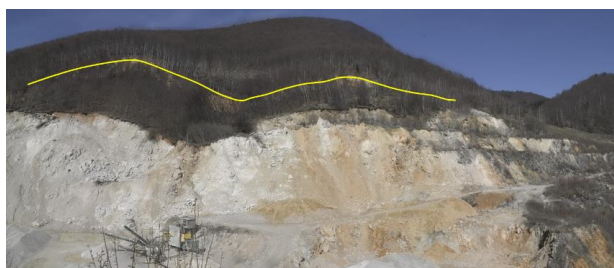
Fig. 1. Southern view of the quarry head scarp

The Kralovany rock slide, which took place in the active limestone quarry (Fig. 1) in the spring of 2013, is one of the most spectacular slope failures in the modern history of Slovakia, both in terms of its dimensions as well as the risk posed to society. It has reached a width of 570 m and a length of 280 m; the volume of the sliding mass has exceeded 2 million m³ and the daily average sliding speed is 1 cm.

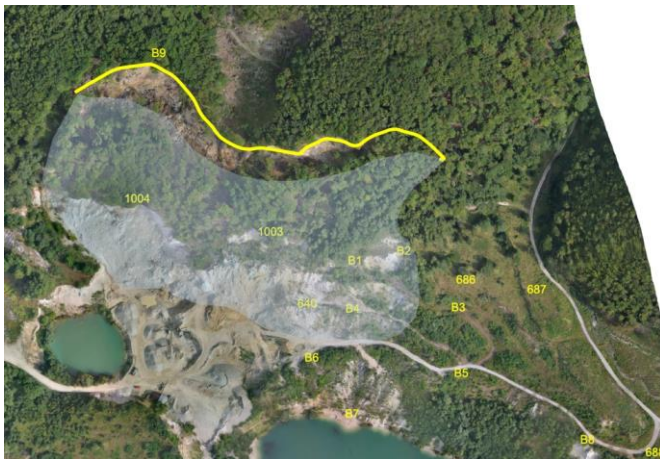
Fig. 2. Top view of the rock slide, its head scarp and arrangement of the observed points. The most active part of the rock slide is highlighted in white shading

Precise point measurement was carried out using the **spatial polar method** using a total station (TS) LEICA TS30, and prisms on the pillars or on a telescopic rod with a bipod and vial (geoharpoons – points labelled "B") or retro-reflective markers. The LEICA TS30 has declared mean angle measurement error of 0.5", the accuracy of the distance measurements to the prism is 0,6 mm + 1 ppm, the accuracy of the distance measurements of the reflective label is 1 mm + 1 ppm and for the distance measurement to the natural surface it is 2 mm + 2 ppm. The configuration of the monitored points is shown in Figure 2.
