Case report

Delayed perforation of posterior pharyngeal wall caused by dislodged bioresorbable interbody cage. Case report

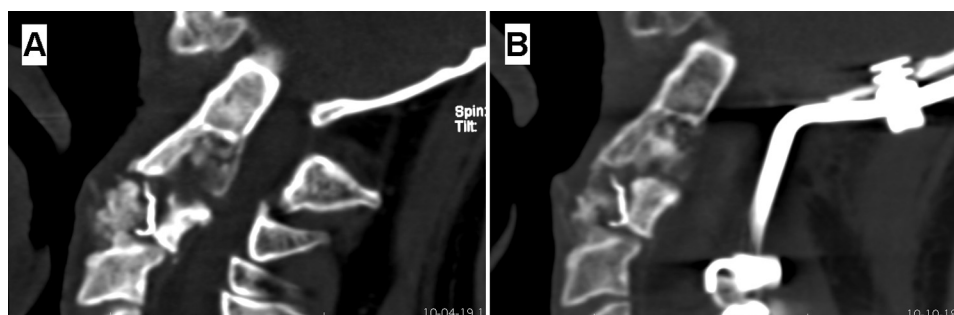
Fig. 2 – Control CT images performed three months (A) and nine months (B) after implantation. There are no signs of Biocage displacement.

A 48-year-old man was admitted for management of Arnold–Chiari type I malformation combined with odontoid upward migration. He also had spinal cord compression by spurs at C2/C3 and C3/C4 levels. Osseous deformities caused ischaemic changes of the brainstem as well as spinal cord compression. According to Nurick scale, the patient's neurological status was assessed as grade IV. He underwent consecutive operations: (1) in July 2009 and in October 2010, subtotal odontoidectomies by transpharyngeal approach – during both procedures total removal of the odontoid peg was not successful due to important bleeding; (2) in January 2010, discectomies of C2/C3 and C3/C4 with removal of the right part of the C3 vertebral body, followed by C2–C4 spondylodesis with Biocage (Fig. 1); (3) in May 2010, decompression of the posterior fossa with C1–C4 laminectomies followed by stabilization between occiput and C7. Computed tomography (CT) examinations (April and October 2010) revealed stability of the Biocage (Fig. 2). The patient was reviewed at follow-up examinations demonstrating improvement to Nurick grade

In order to elucidate the possible cause of Biocage migration, we tried to analyze if this complication might arise from surgical error or other factors. Regarding the surgery, the Biocage was fit to the size of surgically created space between C2 and C4 and tightly placed in its interior. Lack of complementary anterior instrumentation does not explain delayed lack of fusion. Reinforcement of the Biocage by anterior screw-plate system was planned; however, intraoperatively it was ruled out due to
