Durability of current renderings: A probabilistic analysis

A. Silva^{a,*}, P.L. Gaspar^b, J. de Brito^c

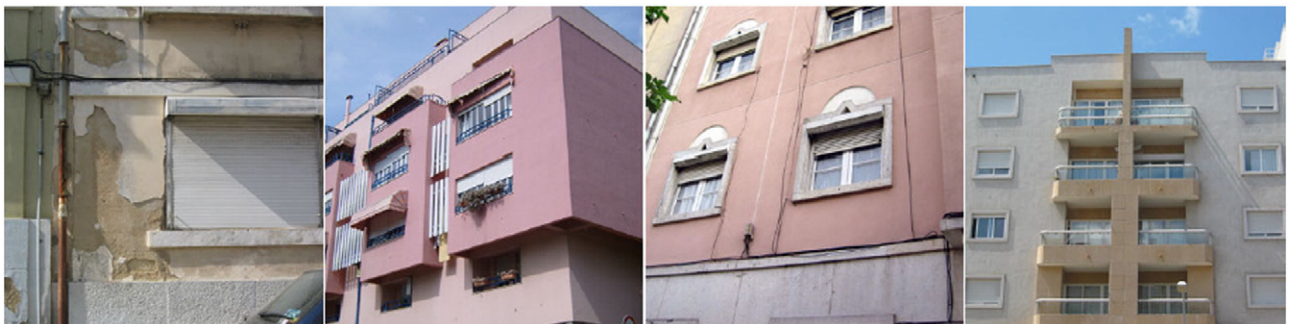
Fig. 1. Examples of the types of mortar in the rendered facades analysed: (a) lime–cement mortar; (b) current cement mortar; (c) mortar with crushed marble; and (d) single-layer mortar.

- i) Lime–cement renderings (Fig. 1a) – made of a mix of cement and lime, usually applied in several coats over the substrate; this rendering is more common in buildings from the first half of the XX century;
- ii) Current cement renderings (Fig. 1b) – made essentially of cement, applied in several coats over the substrate, with a smooth or rough finish; they are the commonest rendering type [6];
- iii) Renderings with crushed marble (Fig. 1c) – similar to current cement renderings, they contain coarser aggregates that confer a rough finishing; this rendering type was particularly trendy in the 50s and 60s of the XX century;
- iv) Single-layer renderings (Fig. 1d) – rich in cement and usually manufactured premixed, they are applied in a single layer; this rendering type started being amply used since the 90s of the XX century.
