Use of digital image processing techniques for evaluating wear of cemented carbide bits in rotary drilling

Omid Saeidi ^{a,*}, Jamal Rostami ^b, Mohammad Ataei ^a, Seyed Rahman Torabi ^a

^a Department of Mining Engineering, Geophysics & Petroleum, Shahrood University of Technology, Shahrood, Iran

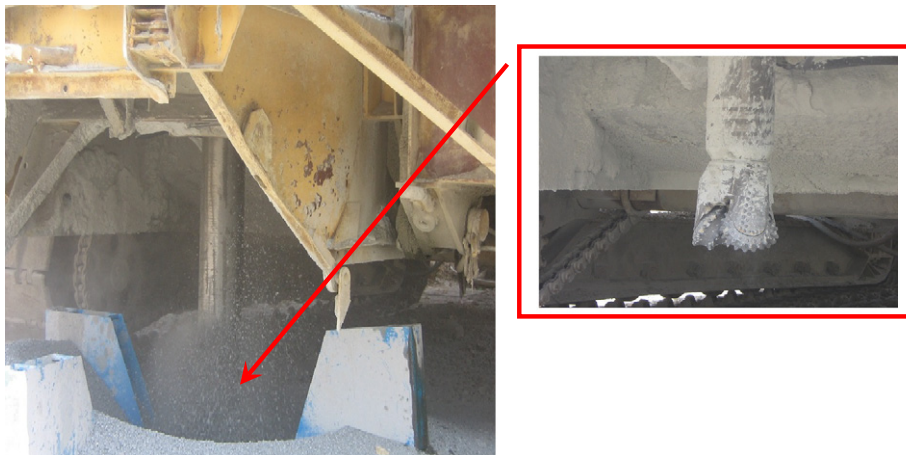
Fig. 1. Close up view of a drill bit during drilling the hole into the rockmass.

The study was carried out on the WC/Co cemented carbide bits at Sarcheshmeh copper mine located in southern Iran. Fig. 1 shows a tricone rotary drill bit mounted on the drill rig during drilling a borehole. The bits are API-RR321 standard type with a diameter of 25.09 cm manufactured by Sandvik Co. They are mounted on a DMH Ingersoll-Rand drill rig to penetrate rock masses. The system involves maximum 20.68 MPa feed pressure on the string, 2.75 MPa air pressure to drag out rock and soil detritus, 200 rpm and 34.47 MPa rotation pressure.
