Case study

Restoration and preservation of the reinforced concrete poles of fence at the former Auschwitz concentration and extermination camp

A. Miszczyk*, M. Szocinski, K. Darowicki

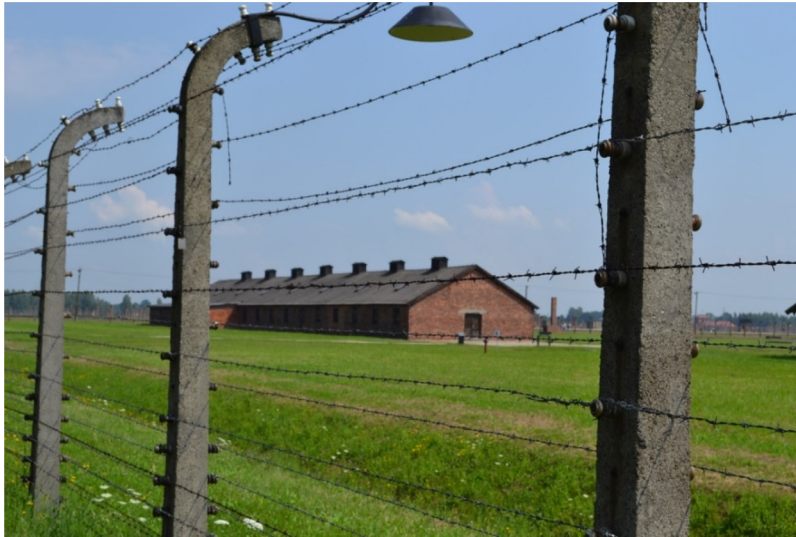
Fig. 1. A fragment of fence and barrack in the former Auschwitz II–Birkenau.
